IMPROVING THE FLOOD RESILIENCE OF BUILDINGS THROUGH IMPROVED MATERIALS, METHODS AND DETAILS

WORK PACKAGE 5 – LABORATORY TESTS

WP5C FINAL REPORT

Ref: CI71/8/5 (bd 2471) July 2006

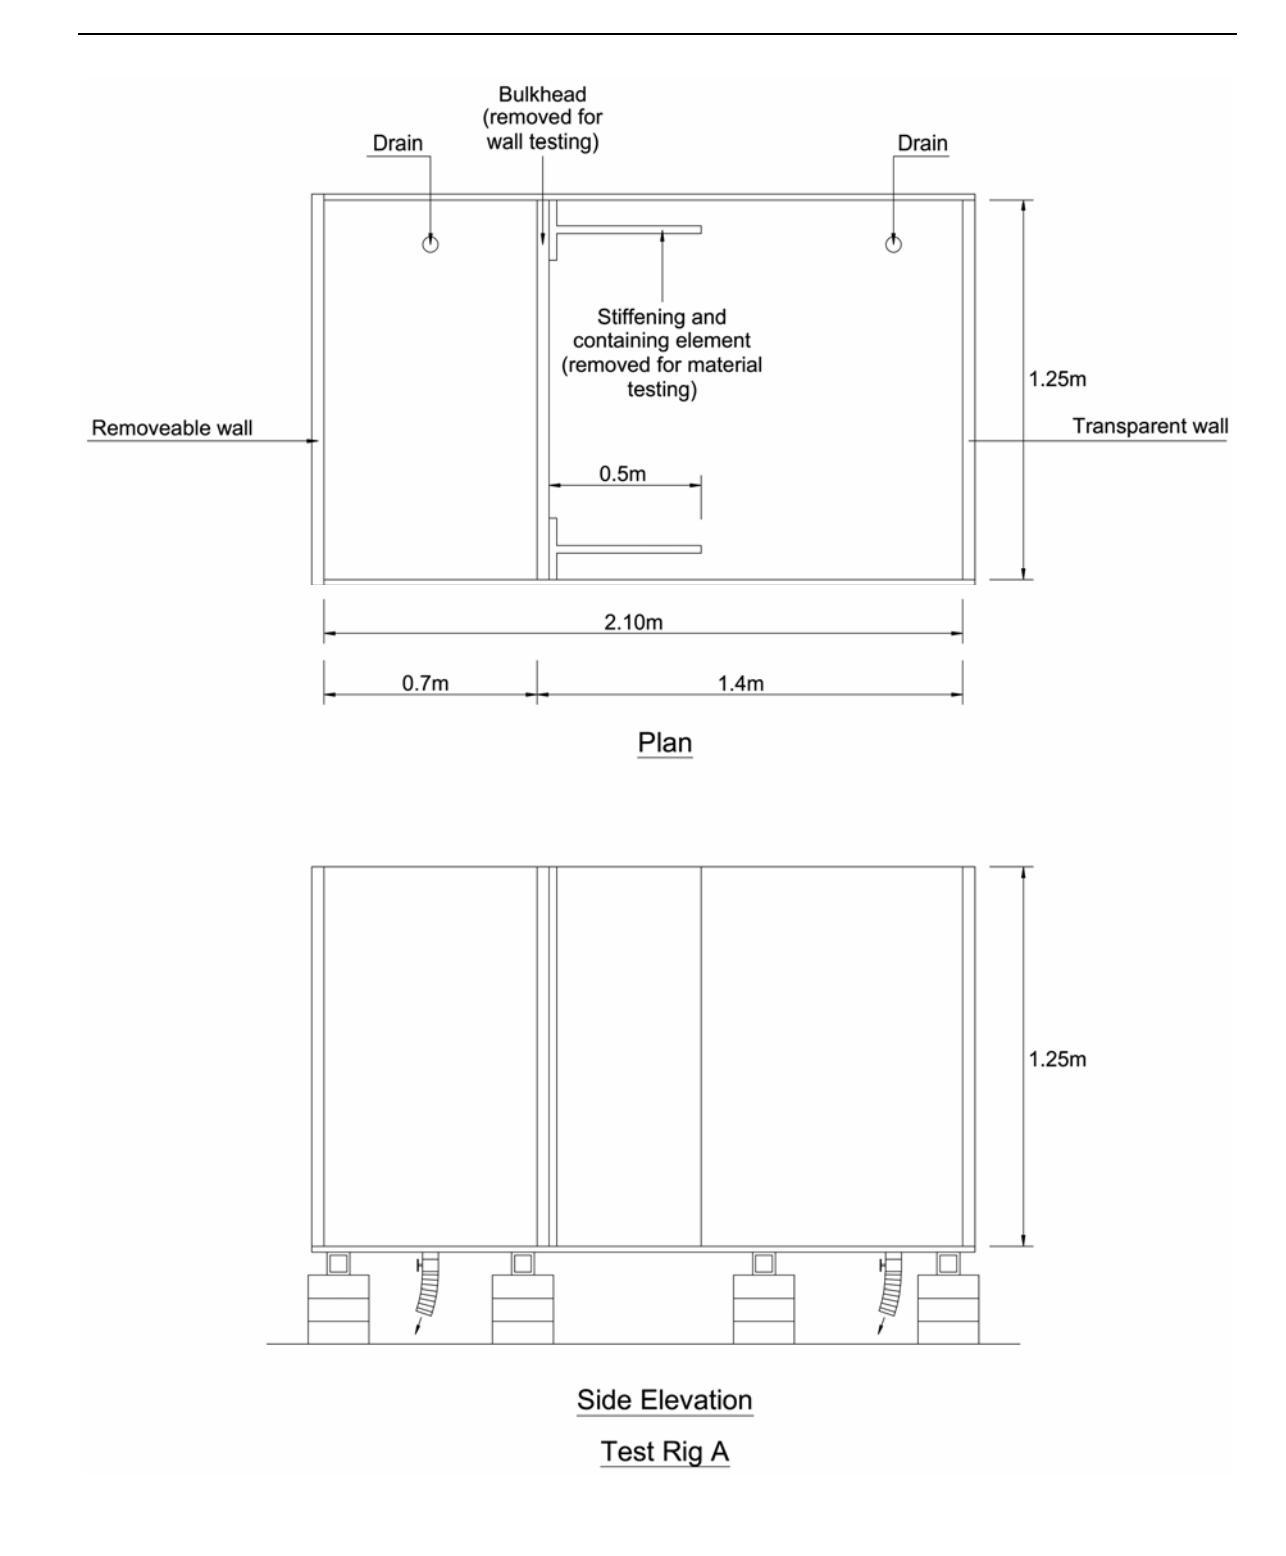
Figure 4.1 Schematic diagram of Test Rig A – Plan and Side elevation

- Removable front wall to allow access for in-situ construction of walls
- Transparent back wall to allow observation of seeped flow and any changes to the appearance of the materials
- Removable bulkhead with openings for simultaneous testing of two specimens of building materials
- Removable stiffening T- elements to allow construction of walls against a fixed surface and to prevent any deformation of the walls and floor of the test rigs from exceeding 1mm deflection
- Drains that could be closed to retain water in the tank on the inside face of the building materials and thereby allow measurement of large amounts of seepage by volumetric means.

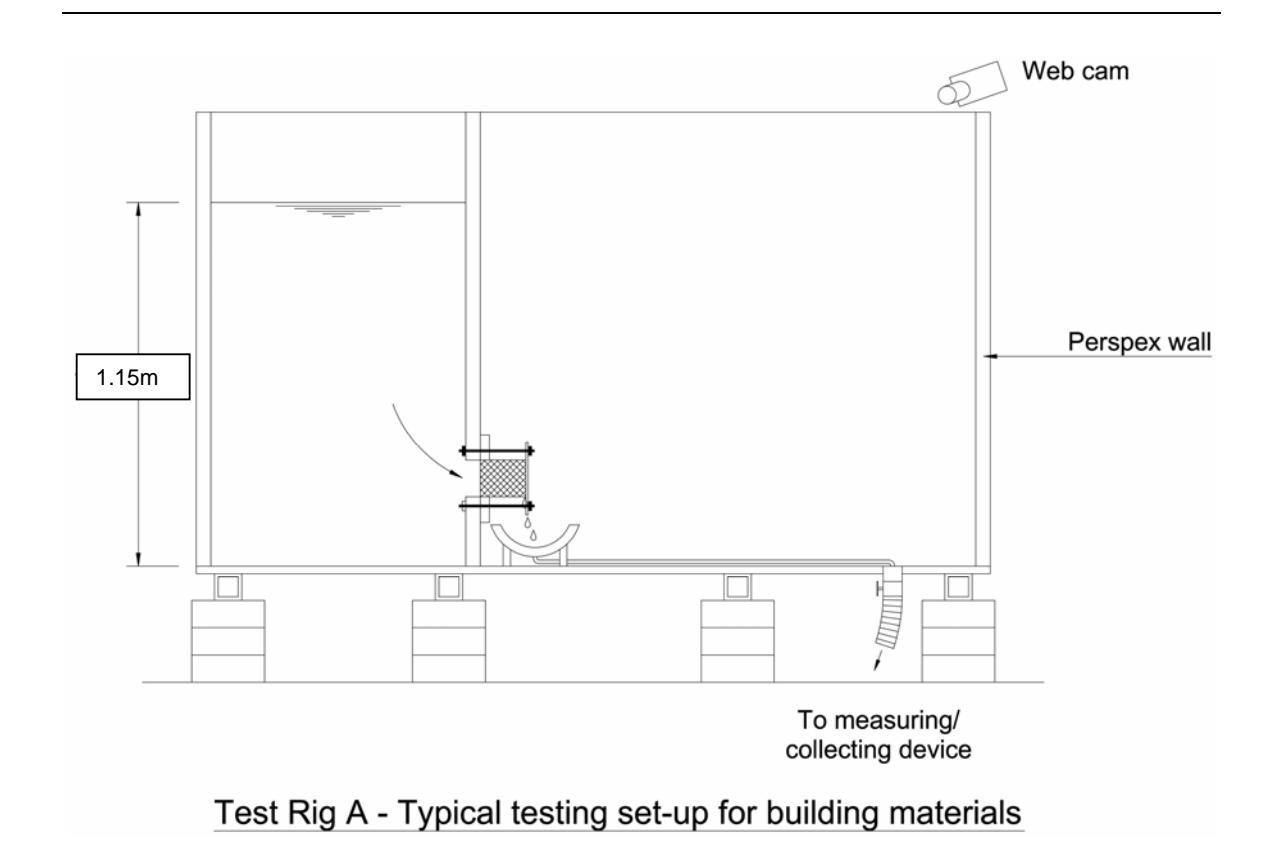
Figure 4.2 Typical arrangement for testing of building materials in Test Rig A

Figure 4.2 shows a schematic side view of Test Rig A with a sample of building material being tested.

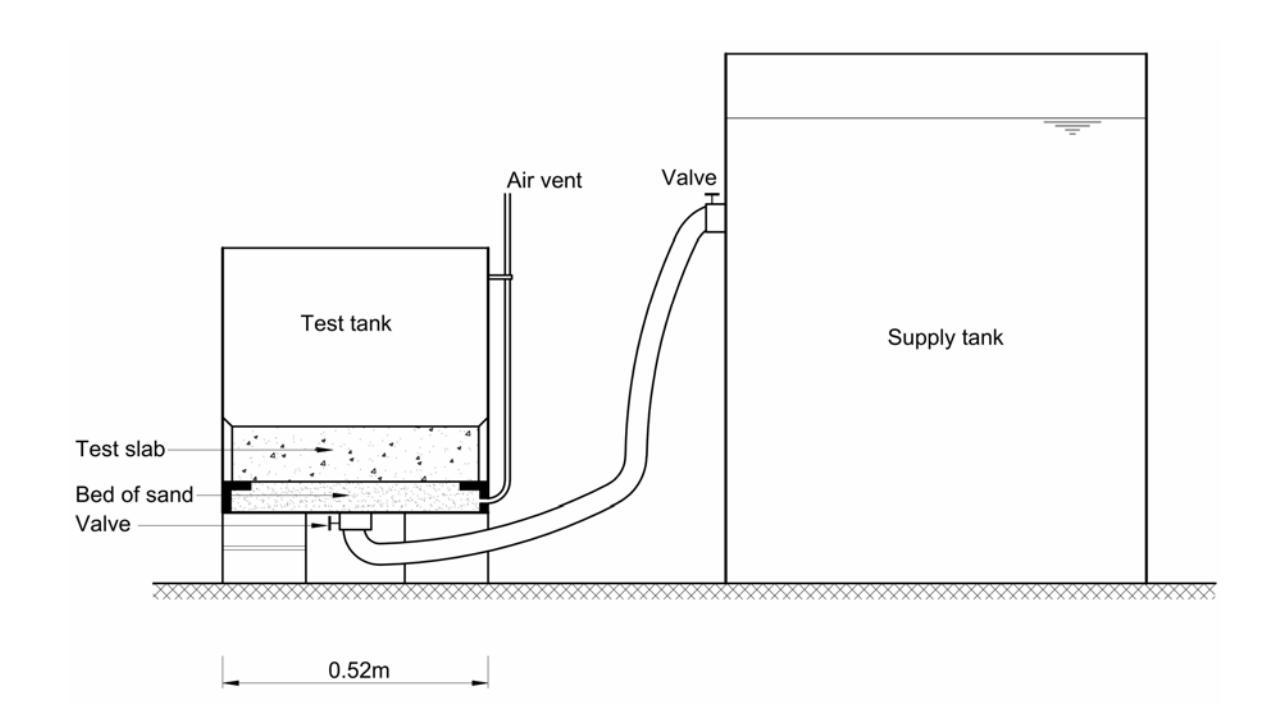
Figure 4.3 Schematic layout of Test Rig B showing set-up for floor slab testing

- Supply tank made of steel, connected to test tank by flexible hose
- Test tank made of steel, 0.52m by 0.52m (base) and 0.60m (wall height) with weir to allow overflow. A metal angle was placed around the internal perimeter of the tank to allow sitting of the pre-cast slabs. At the base of the tank a grid and geotextile were introduced to prevent sand loss through the supply pipe
- Air vent pipe connected to the test tank to allow escape of air from the sand base
- Fixing metal frame to counterbalance uplift forces caused by 1m head of water (not shown in Figure 4.3).

Alterations to the inside of the test tank were undertaken for the testing of floor/wall junctions to permit the construction of foundation walls.

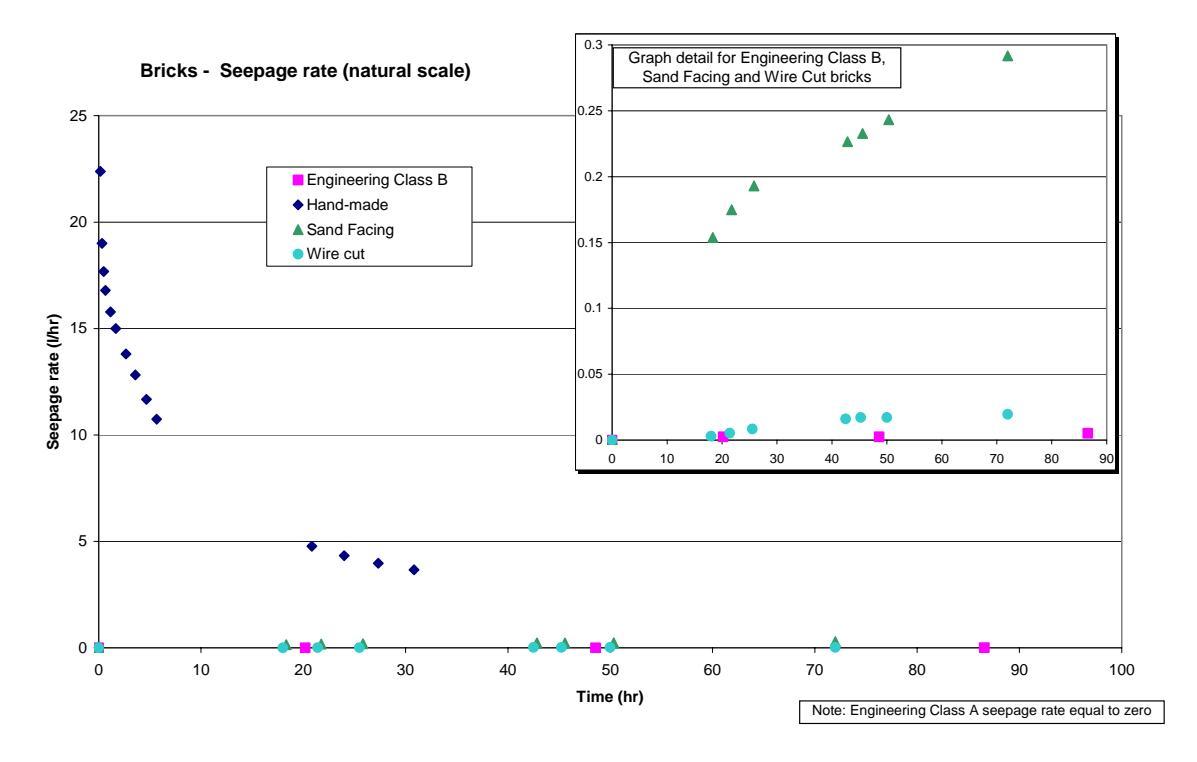
Figure 6.1 Comparison of seepage rates for the bricks tested (natural scale)

It was mentioned before that the response of the various materials to exposure to 1m depth of water was extremely variable, even within each category of materials, e.g. bricks, blocks, etc. This variability was found both in terms of seepage rates and seepage behaviour, i.e. evolution with time. Whereas some materials showed the peak seepage rate at the start of exposure to 1m depth of water (or soon after) and a decline with time (e.g. hand-made brick (Figure 5.8), concrete block 7N (Figure 5.12), timber board (Figure 5.16)), others showed a gradual increase in rate with time, extending beyond the wet test duration (e.g. sand facing brick (Figure 5.4), concrete block 3.5N (Figure 5.10)). Figures 6.1 and 6.2 show a comparison of seepage rates for the brick types tested, in natural scale and logarithmic scale respectively (due to the wide range of seepage rates, logarithmic scales are required to allow comparisons to be made). Equivalent graphs are shown in Figures 6.3 and 6.4 for the blocks tested. Figures 6.5 and 6.6 were produced for comparison of the two types of timber board and mortar tested, respectively.

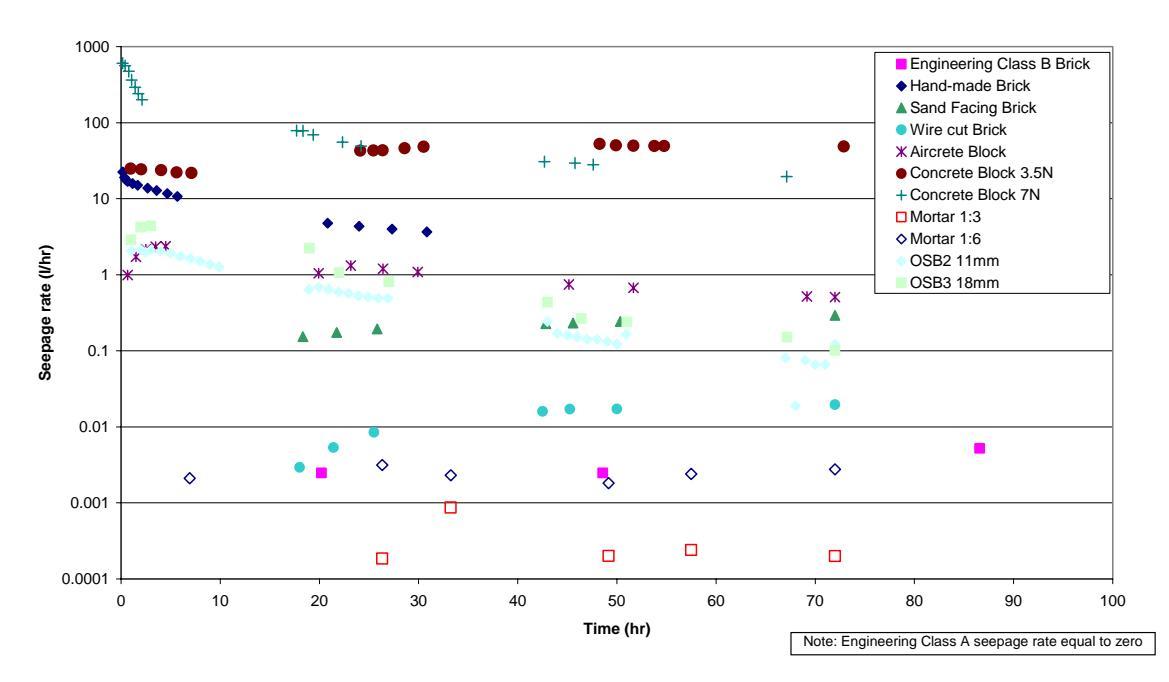
Materials seepage rate (logarithmic scale)

Figure 6.7 shows a graph of seepage rate evolution with time for all the materials tested. In general terms, concrete blocks showed the highest seepage rates whereas mortar and engineering bricks provide the lowest water penetration. Seepage rates varied by more than a factor of 10^6 .

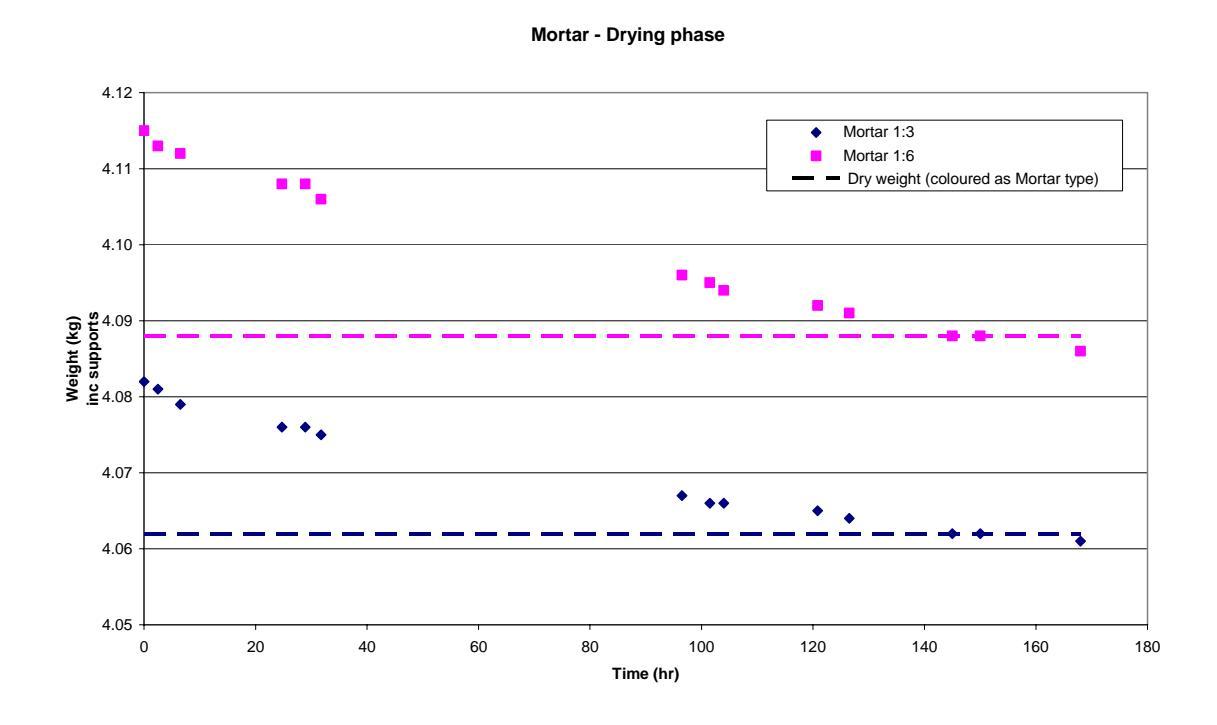
Figure 6.11 Comparison of drying times for the mortar samples tested

The two types of mortar samples tested showed similar behaviour as can be seen from Table 5.1 and Figure 6.11, recovering their dry weight before the seven day drying period was over.

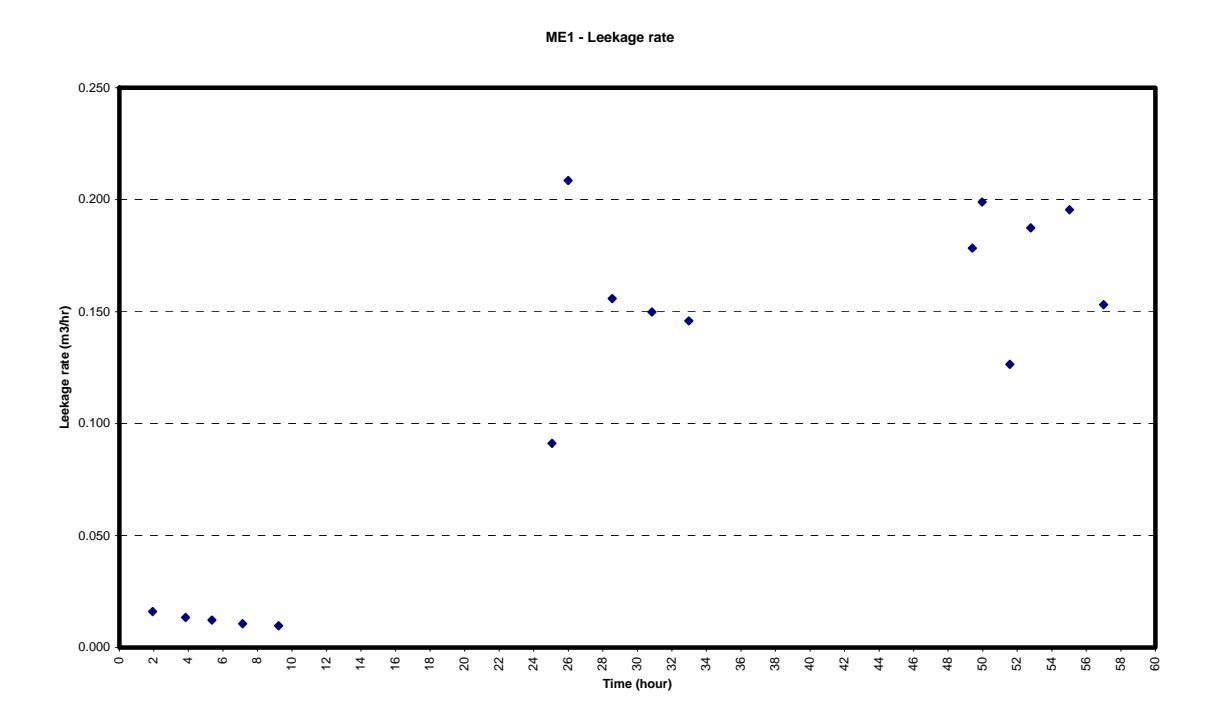
Figure 7.1 Wall ME1; Leakage rate – Evolution with time

As can be seen from Figure 7.1, wall ME1 developed a leak between 10 and 25 hours after the start of the wet test (this occurred during the night period; study of the web cam photos did not provide conclusive answers as to the start time of the leak). It was not possible to ascertain where the leak originated but it produced a marked increase in the leakage rate through the wall. It is considered that the long term (steady state) leakage rate through ME1 was achieved before this leak occurred and this value was comparable to the long term rate through ME2 (compare Figures 7.1 and 7.2). However, it has to be acknowledged that cracking or some other failure could be the long term performance of the wall subjected to flood water for several days.

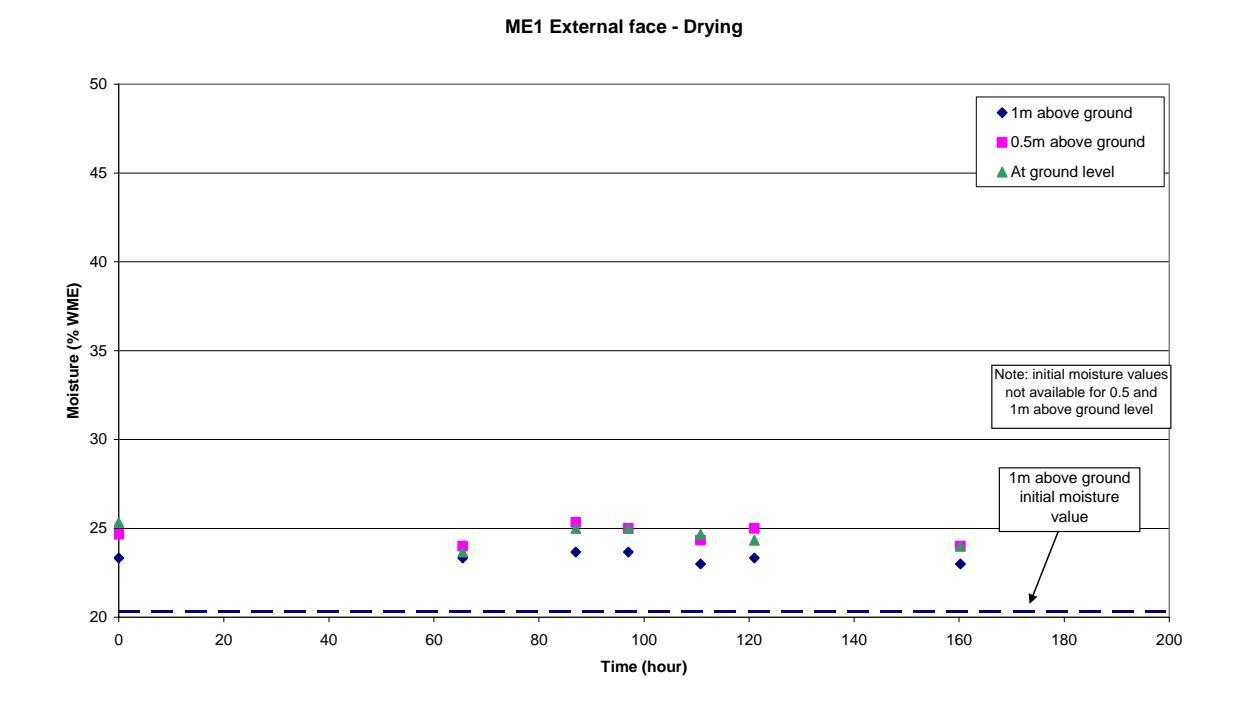
Figure 7.3 Wall ME1; External face – Evolution of drying with time

The drying tests revealed that, as expected because they were similar, the external faces of the two walls had very comparable behaviour (see Figures 7.3 and 7.4), with an increase of 15% in moisture (WME) from their dry state. This is higher than expected, based on the bricks performance alone (which had water absorption of only 0.3% based on increased weight) and is therefore to be concluded that it must be due to the combined effect of bricks and mortar joints. However, it must be noted that different techniques have been used to determine the water absorption of materials as opposed to the walls, so the results are not entirely compatible. Also, the drying of the walls in their constructed state is necessarily different to the drying of the materials.

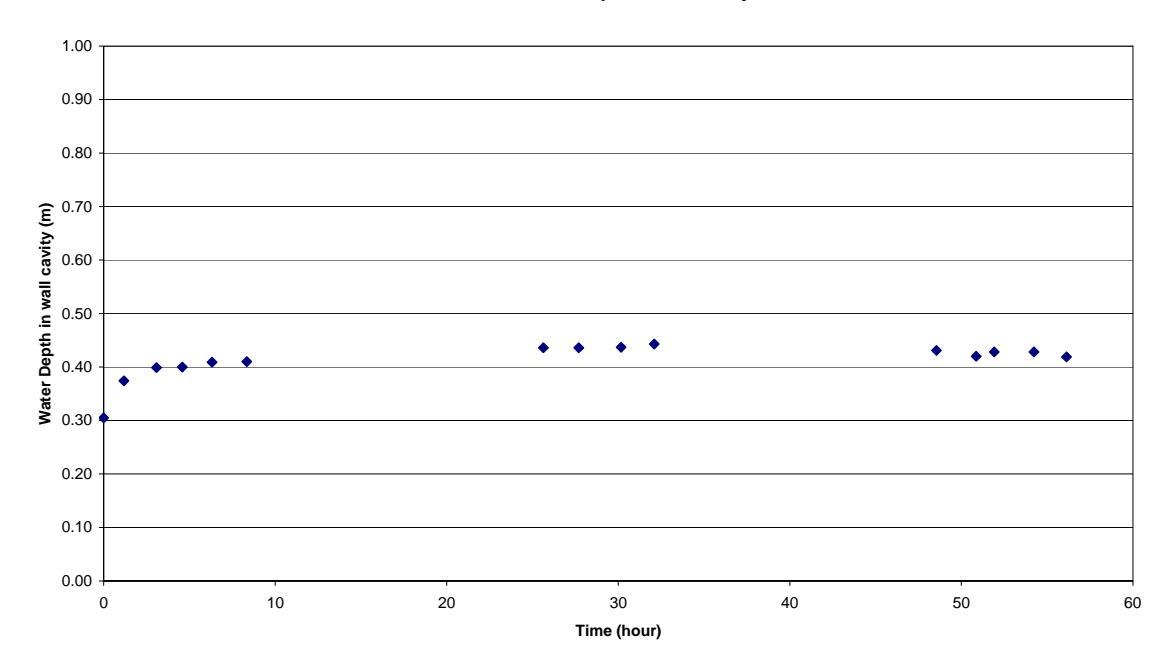
Figure 7.8 Wall ME2; Depth of water in wall cavity – Evolution with time

Figures 7.7 and 7.8 show the increase in water depth inside the cavity wall for the two walls, respectively. The depth of water reached a constant level of about 0.120m for ME1 (after the leak developed this increased to about 0.450m) and 0.420m for ME2.

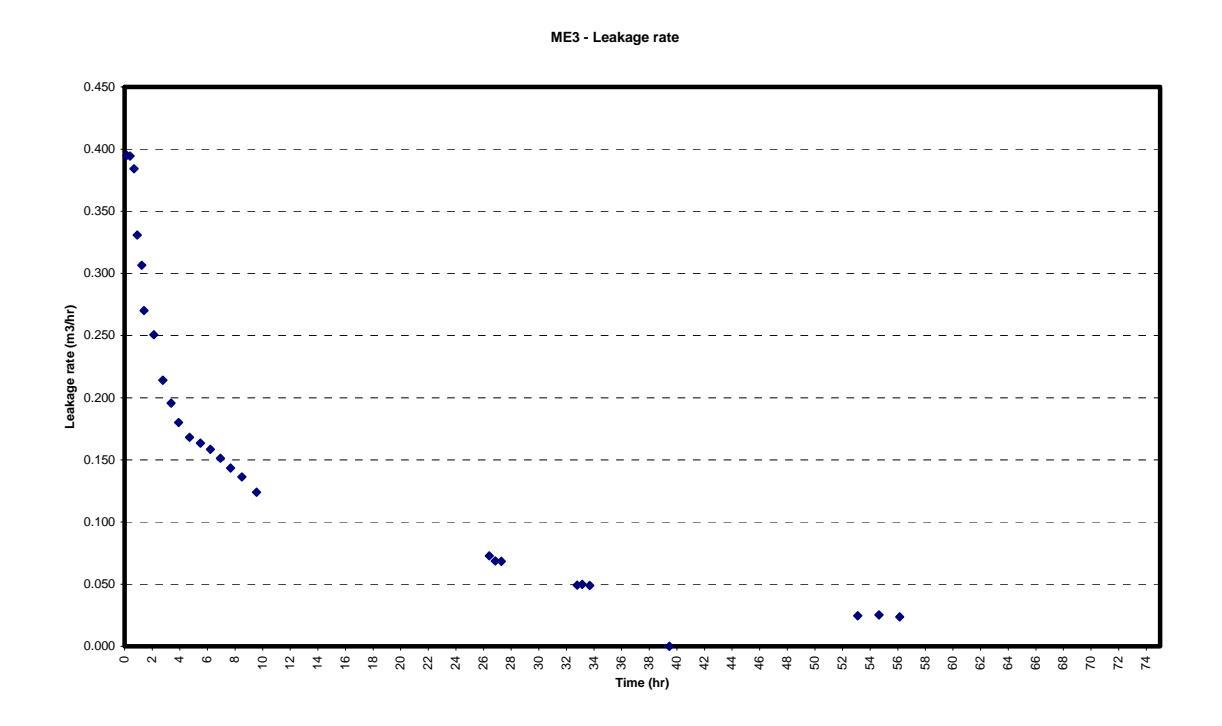
Figure 7.9 Wall ME3; Leakage rate – Evolution with time

Figures 7.9 and 7.10 show the evolution with time of the leakage rate through walls ME3 and ME4, respectively. Both walls show a similar leakage curve, with maximum values of leakage rate at the start of the test and then declining to a constant rate of about 25 l/hr. The initial leakage from Wall ME3 was larger than for wall ME4.

The main objective of testing Wall ME5 was to compare its performance with that of wall ME3, which was similar to ME5 in all respects apart from the lack of external render. Figure 7.27 shows the evolution with time of the leakage rate through wall ME5. At the start of the test, no leakage was observed and the rates were several orders of magnitude smaller than those observed for wall ME3 (see Figure 7.9) – note the different scales in the two graphs.

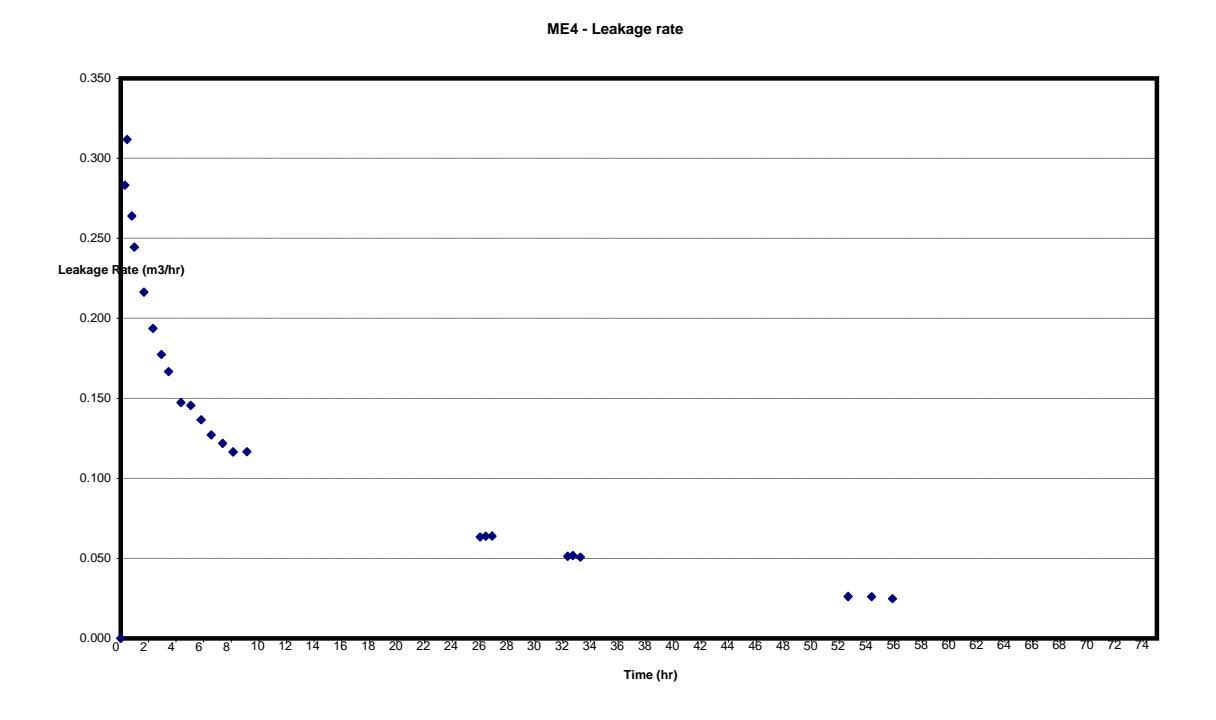
Figure 7.10 Wall ME4; Leakage rate – Evolution with time
The drying tests revealed that, although the external wall face was constructed with the same materials in both walls ME3 and ME4, wall ME3 retained more moisture than ME4 during the drying phase (see Figures 7.11 and 7.12), with an increase of up to 50% in WME from its dry state (compared to about 10% for wall

When comparing with ME4 (see Figure 7.10), which is similar in construction to MFF1 and MFF2 but had an empty cavity, it is apparent that the evolution of seepage with time observed for MFF1 is similar to that of ME4, although the maximum leakage rate in MFF1 was somewhat higher. This indicates that using mineral fibre as cavity insulation has little effect on the leakage into the interior of the building.

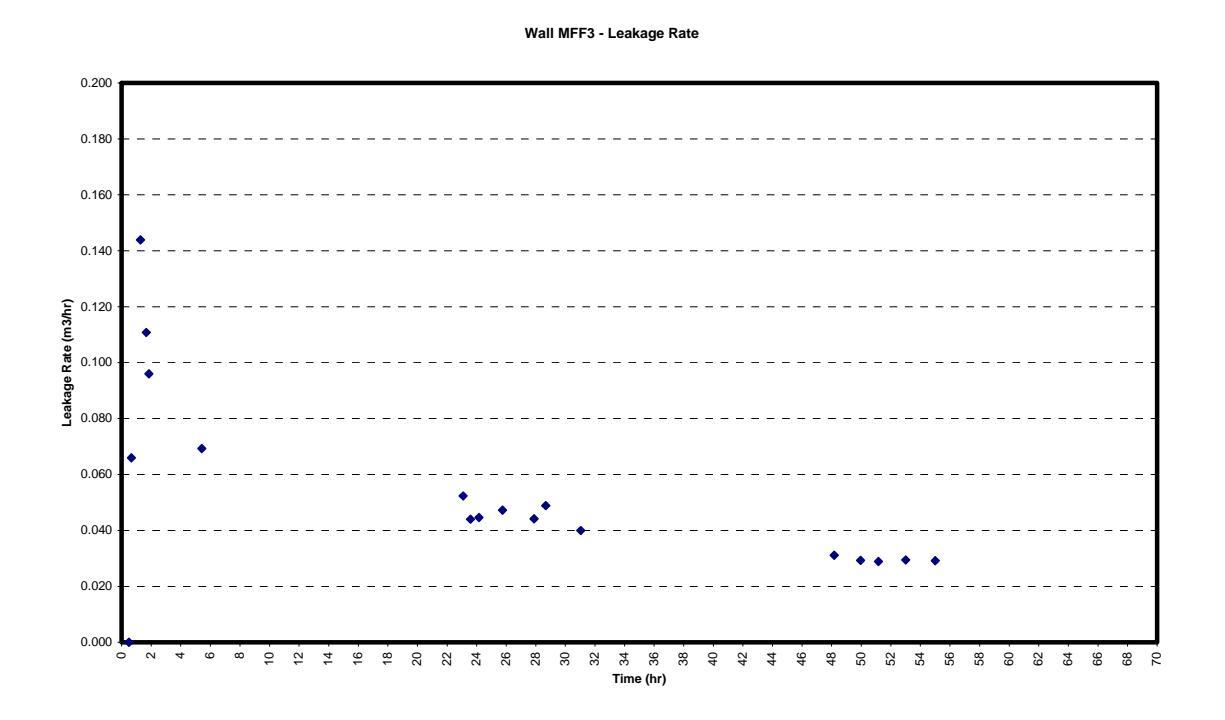
Figure 7.31 Wall MFF3 - Evolution of leakage with time

The main objective of testing Wall MFF3 was to investigate the behaviour of lime plaster, in particular to compare its performance with that of standard gypsum plaster board. Soon after the wet phase test started (1m head of water on external face) the lime plaster cracked and detached from the wall; this occurred at the level of the damp proof course (see Photo 7.20). Large leakage rates were observed, as can be seen in Figure 7.31. When exposed to water on both the external and internal sides, the lime plaster started to crack also at the surface water level, as shown in Photo 7.21. The lime plaster disintegrated completely and therefore it was impossible (as well as irrelevant) to take moisture readings relating to the drying phase. It is appreciated that lime plaster requires several months (or even years) to reach its full properties and the timeframe of the testing programme would not allow for that. Further discussion is given in Chapter 8.

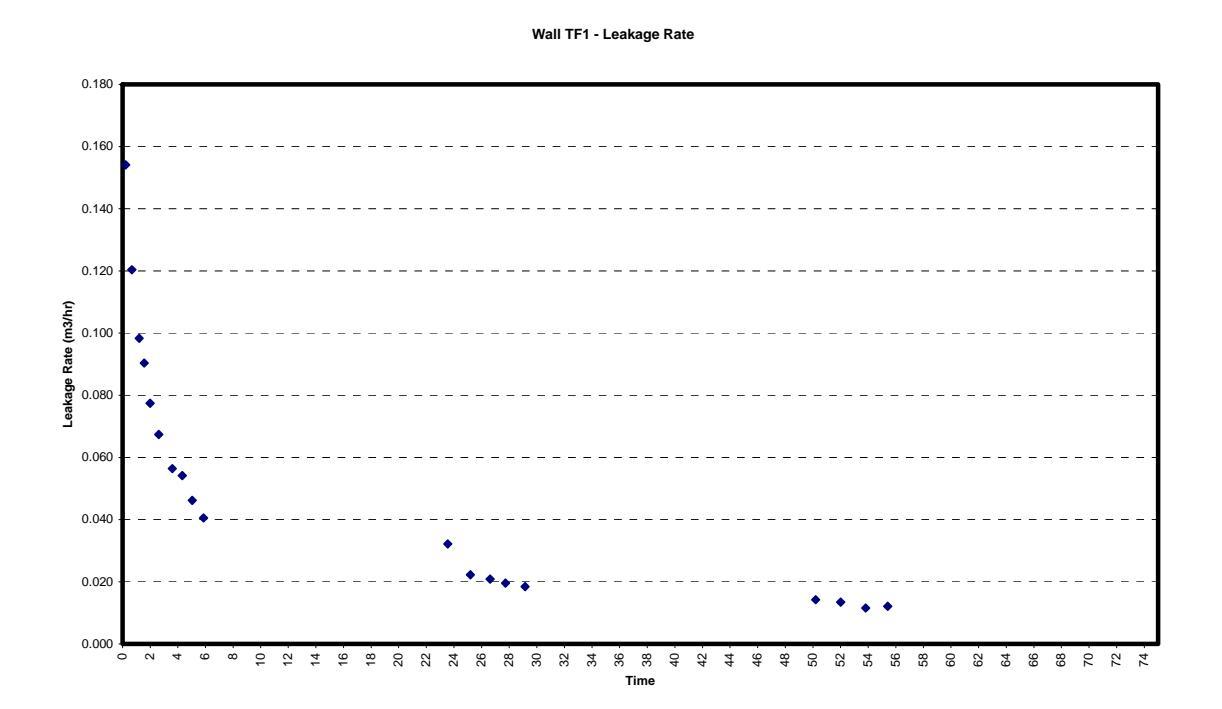
Figure 7.32 Wall TF1; Evolution of leakage with time

Wall TF1 was a timber framed wall with Wire cut facing bricks on the external face and empty cavity (other components are listed in Section 7.1). Lower leakage rates were measured (see Figure 7.32) when compared with a typical masonry wall such as Wall ME4 (see Figure 7.10). This is likely to be attributed to the presence of the OS Board on the internal wall construction, which has lower seepage characteristics than concrete blocks (see Table 5.1). Photo 7.16 shows the installation of insulation within the timber frame. It is worth noting that, although representative of general practice, the workmanship appears poor from an insulation viewpoint as relatively large gaps can be seen. However, this is unlikely to impact on flood performance.

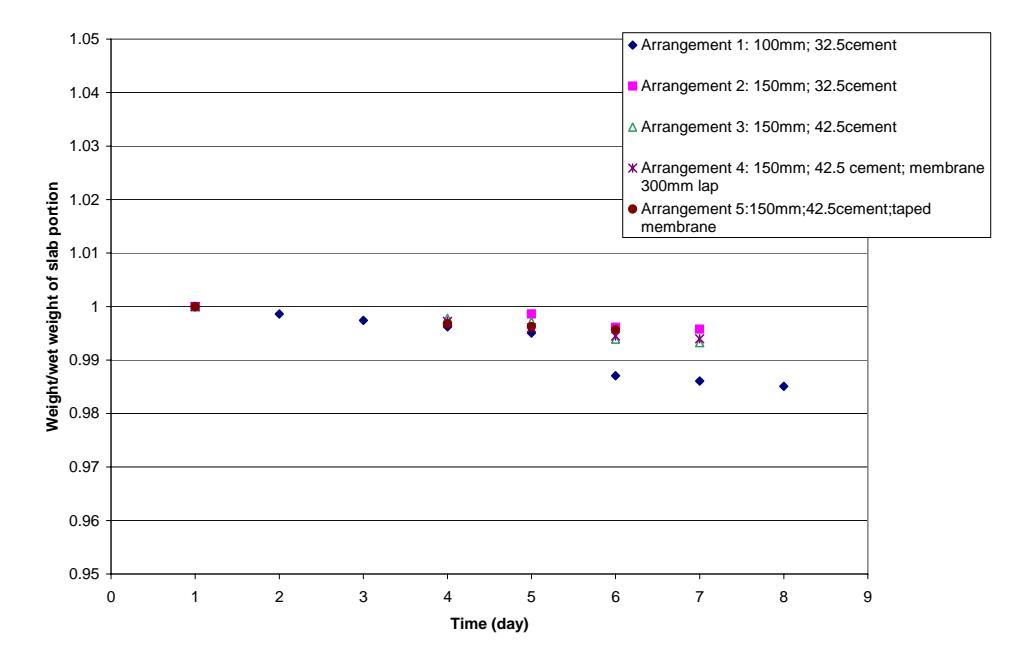
Drying rates of concrete slabs - Arrangements 1 to 5

Figure 9.1 shows the evolution of drying of a broken-off corner of the test slabs for Arrangements 1, 2, 3, 4 and 5.

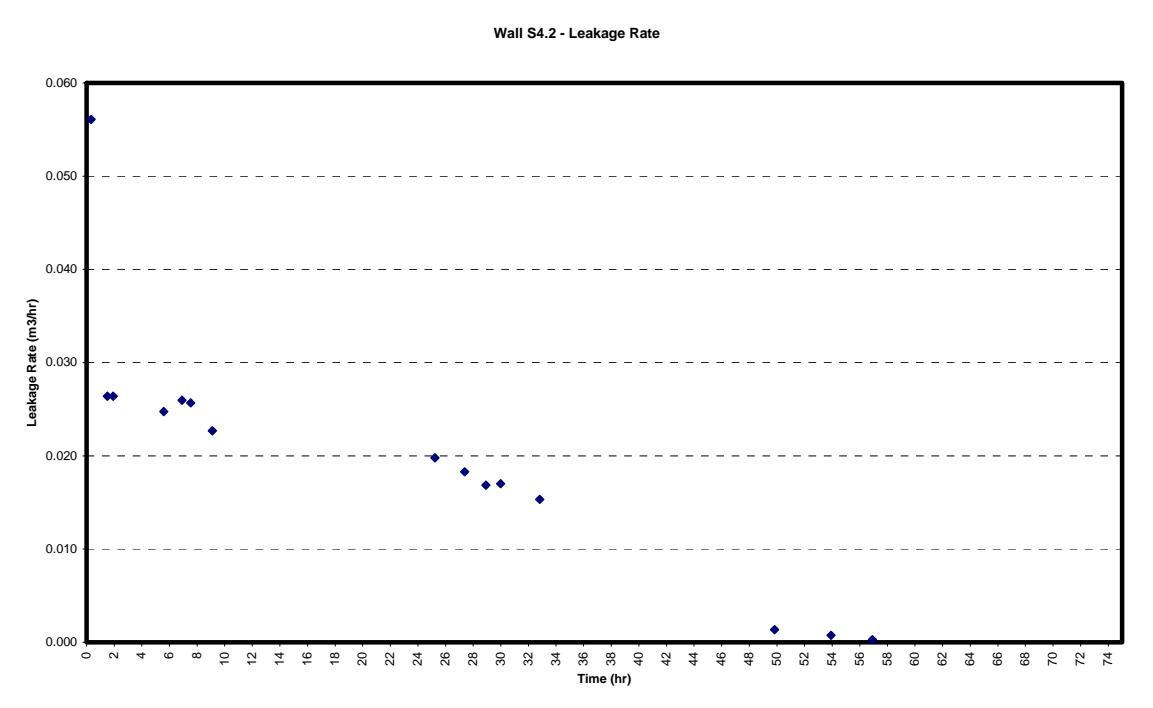
Figure 10.3 Wall S4.2 Wall with external insulation - Evolution of leakage with time

Measurable leakage of the order of 25 l/hr was observed through this wall but this ceased after 57 hours (see Figure 10.3). The maximum leakage rate observed was one order of magnitude higher than that measured for other rendered walls and this behaviour may be associated with the sealant at DPC level which was not necessarily designed to withstand 1m head and be fully watertight. Some limited crumbling of the internal proprietary render was also observed (see Photo 10.10).
