IMPROVING THE FLOOD RESILIENCE OF BUILDINGS THROUGH IMPROVED MATERIALS, METHODS AND DETAILS

Ref: CI71/8/5 (BD 2471) February 2007

REPORT WP6 – COLLATION AND ANALYSIS OF POST-FLOOD OBSERVATIONAL DATA

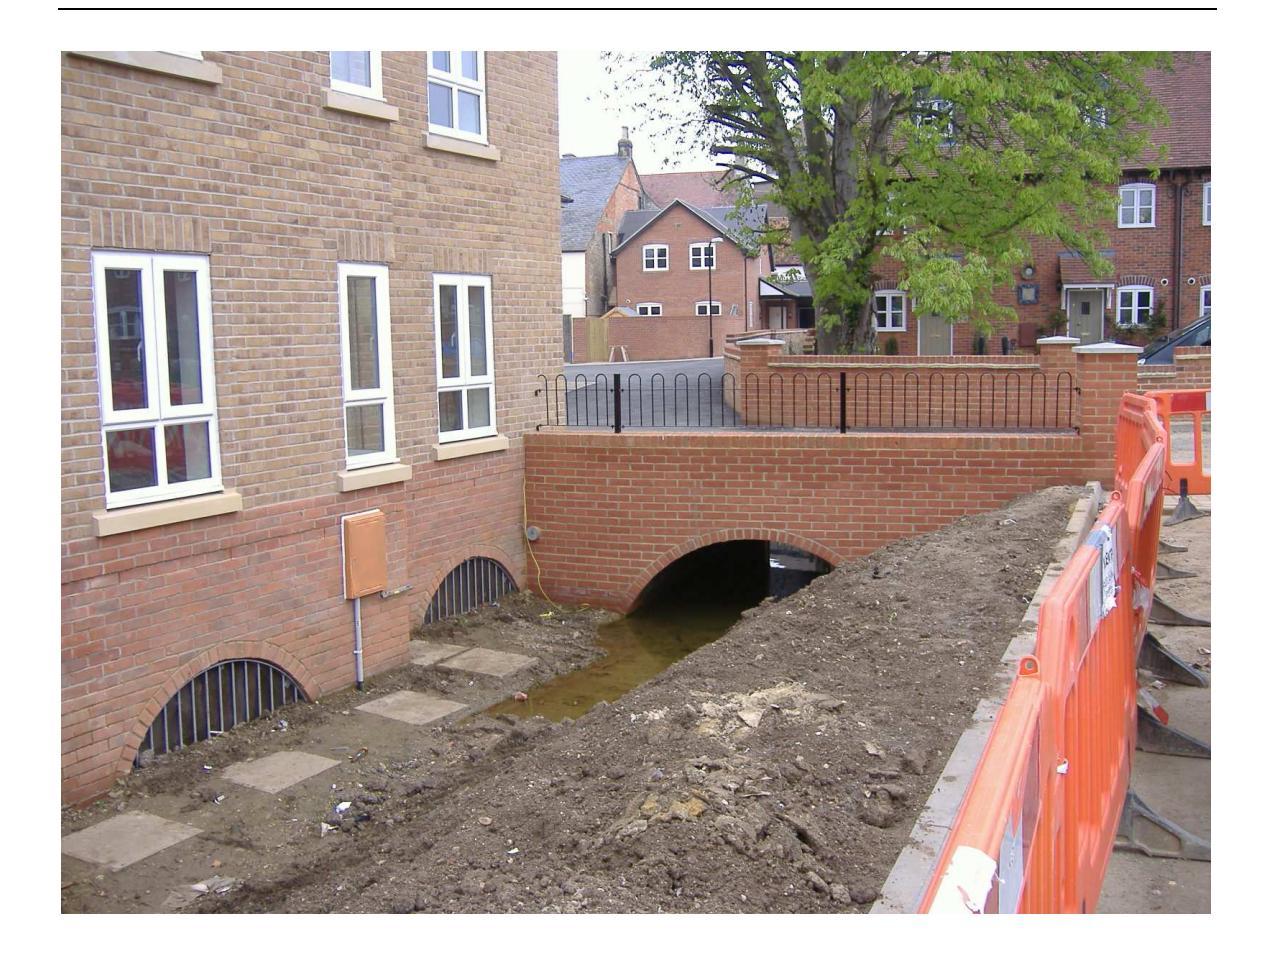
The Social Housing Manager for Leadbitter indicated that their design philosophy is not to use flood protection measures, or indeed resilient measures for their developments. Rather they prefer to work with the natural flow routes of watercourses and overland flow. So rather than trying to protect the house from water ingress, they use trenches and other flow routes underneath the houses to allow the water to move away as quickly from the building. Each case will be looked at on a site-specific basis, and will utilise a flood risk assessment to inform the best 'hydraulic' solution. If they install flow routes under the building, they will sometimes suspend the drainage to the underside of the slab. They therefore do not consider resilience in their designs, as we are defining it in this project, although they will use brick and blocks of a certain quality to withstand flood water. Plate 1 shows a new development in Bicester, Oxfordshire, where they are allowing water to flow under the house from the adjacent ditch.

Plate 1. Use of engineered flow paths under new development in Bicester, Oxfordshire (Leadbitter Construction)

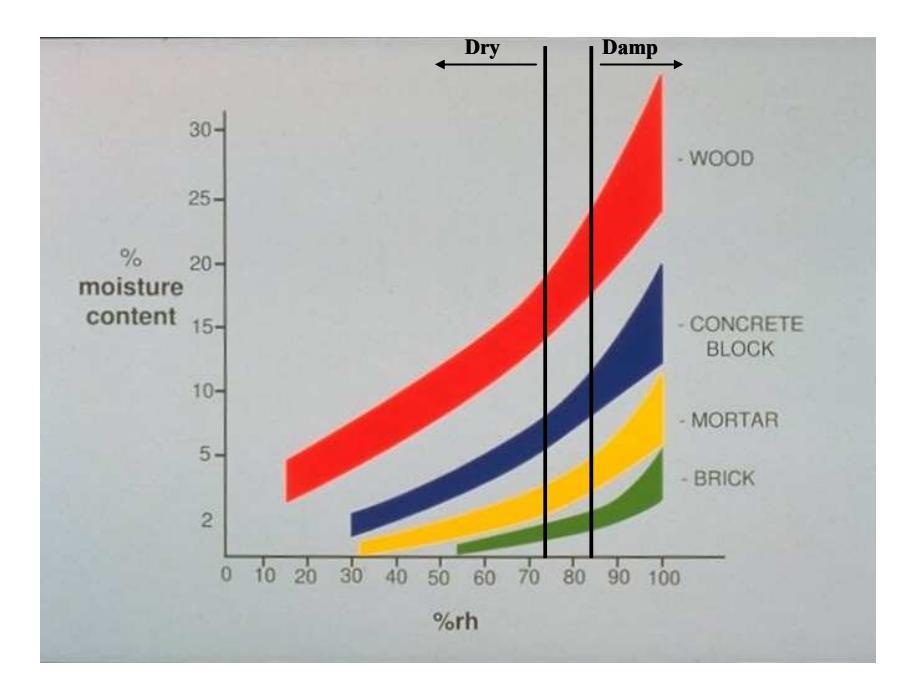
In the past, GE Industries, who produce the Protimeter, used to provide generic tables relating WME to actual moisture values. However, because the information was being misused or misinterpreted, the normal practice within the industry now is to only quote %WME, which provides a consistent approach as long as it is clear that this only applies to surface readings. The following figures (2 and 3) show the generic moisture curves for different materials. The values are Equilibrium Moisture Content (EMC), which means that they have stabilised with respect to the relative humidity of their environment. 16% WME acts as a 'magic number'. separating dry materials from those that are at risk, since it has been found that biological attack, in the form of dry rot, starts to take place above this important threshold. The consequence of this relationship is that if a set of wall elements was found to have the same % WME of 20% (at risk), the wood would be at 20% EMC, plaster at 1-3% EMC, bricks at 2-5%EMC, and the cement mortar at 5-7%EMC. This is obviously a simplification of what is likely to happen in reality, because it assumes equal 'wetting' of all the materials and doesn't allow for interactions between them or variation in the material compositions. But it does illustrate how surface moisture readings can be difficult to interpret from actual building elements.

Figure 2 Generic equilibrium moisture content (EMC) curves for different materials (reproduced courtesy of GE Industries)

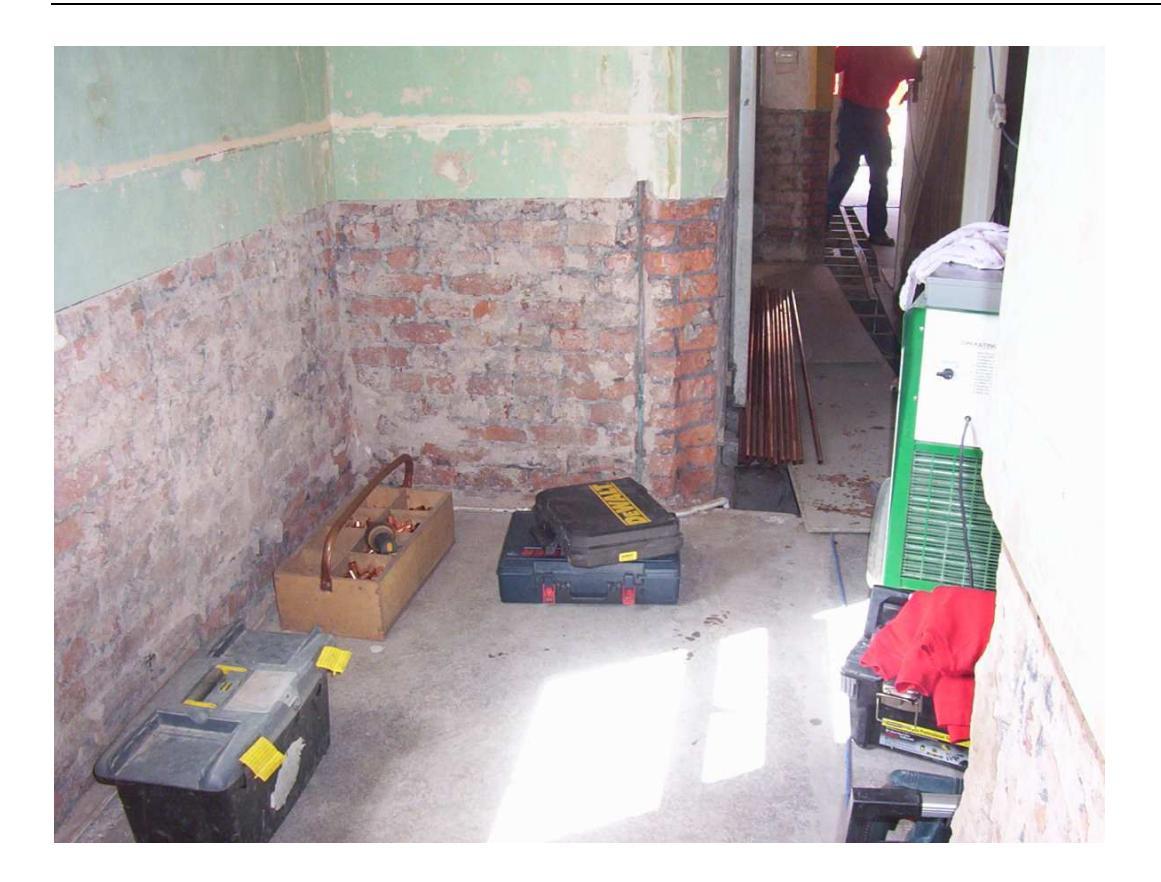
Moisture data were provided for 375 locations in 35 households from Carlisle, with surface readings taken in various external and internal walls. An example is shown in Appendix 4 (note that values are quoted as REL ('relative') where 20% WME is 200 REL; i.e. they are simply multiplied by a factor of 10, which seems to be an approach used within the industry). There was no record of the type of material that was tested (e.g. wood, brick), nor of the type and number of drying units used and the subsequent energy use. However, it has been confirmed subsequently that all walls were made of brick, with all saturated plaster being removed prior to commencement of the drying (see Plate 2). Drying targets were set according to unaffected areas, although because several of the properties had problems with existing DPCs, the 'normal' moisture was higher than the 16-20% WME expected. Because Rameses tanked the walls, they were able to commence reinstatement before the normal drying target was achieved (i.e. when most readings were still in the mid to high 20s). The amount of drying equipment needed in each property was determined by the Moisture Wizard which can be found the National Flood School web software. on site (www.nationalfloodschool.co.uk/isd mw pas64.htm). This assesses the room dimensions, relative humidity and air temperature, and recommends the amount of air movers and dehumidifiers required.

Plate 2. Example of wall monitored by Rameses in Carlisle (April 2005)

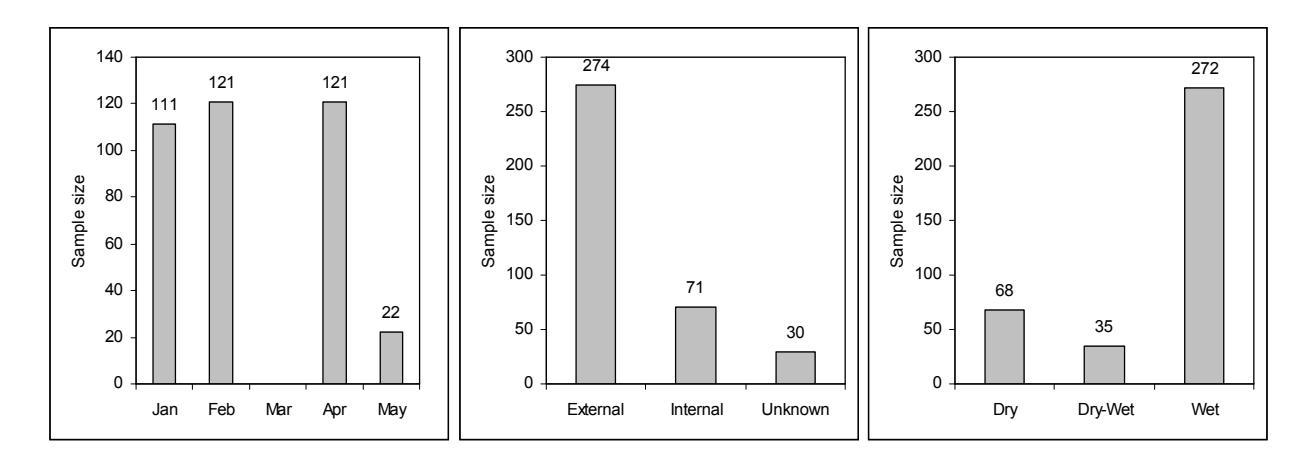
Moisture readings were taken over the period January to May 2005, and Figure 4 summarises the distribution of the readings, noting the month in which readings started. So readings in some houses only started in April (n=121 locations). Visits took place throughout the whole period, with readings generally in external walls and in ones that were wet and which then dried. Some walls were assessed as being largely dry and which remained so during the period, although their values have been included in any global analysis (so the average house drying rate will be lower as a result). Some walls appeared to start dry and then got wetter as the time went on. This may not be surprising, given these are surface readings, which could be affected by presence of salts, location of the probe relative to the materials and moisture in the walls. This just highlights the inherent difficulty in how to measure the wetness or dryness of a wall.

Figure 4. Distribution of samples in the study period (January, February, April, May). Location of sampling points (external walls, internal walls or unknown). Conditions at sample points (dry during the whole study period, dry at the beginning of the study period but wet later on, wet at the beginning of the study period; n = 375 sampling points located in 35 houses).

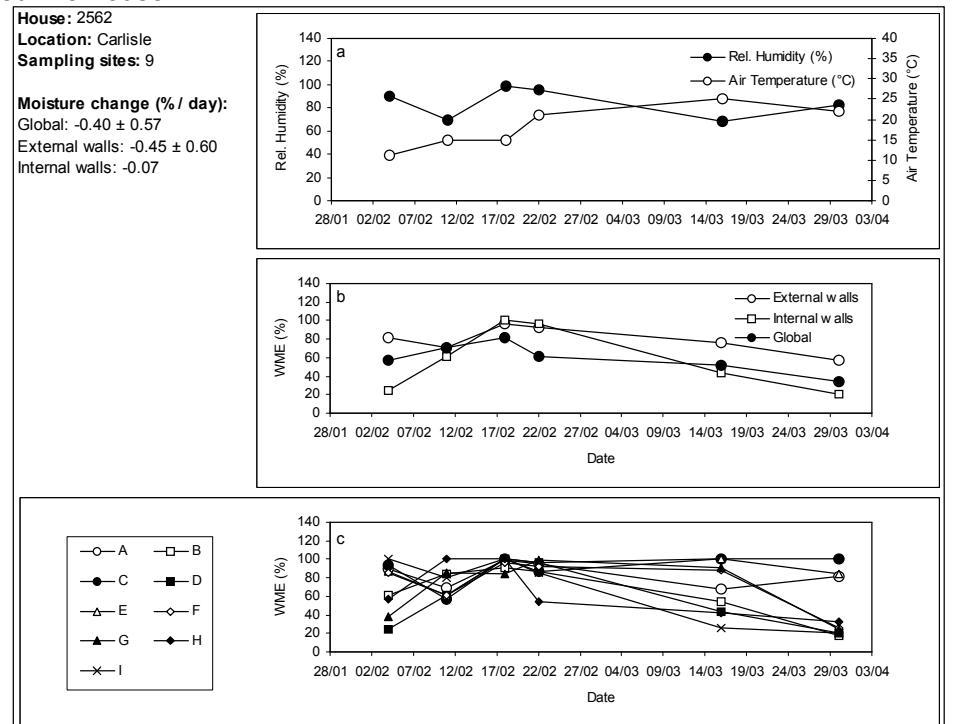
Figures 5 and 6 present examples of the data collected for two houses, showing the change in ambient conditions and moisture content from February to March. There is considerable scatter in the moisture readings at the various sampling locations (A to J), reflecting either redistribution of moisture during the drying process and/or the accuracy of the equipment used and the way it was applied. See Appendix 4 for an example of where the sampling points may be located in a house.

Figure 5. Moisture changes in property 2562.

In the above figures, 'Global' refers to the statistics for the whole house, which can be compared to those calculated separately for external or internal walls. It should also be noted that drying rates have been expressed as a negative change in %WME per day. Figure 7 presents the initial and final moisture values for each sampling point, again summarised on the basis of when the location was first sampled. So one can see a very slight decrease in the initial moisture from January to May, although very little difference in the corresponding final values. As one would expect, the external and 'wetter' walls show the biggest change in moisture level. The corresponding change in moisture content (drying rate per day) is shown in Figure 8. This again confirms that the largest changes are seen for external and wet walls, although interestingly, the largest drying rate (-1.55 %WME/d) occurs for locations that were measured from April onwards.

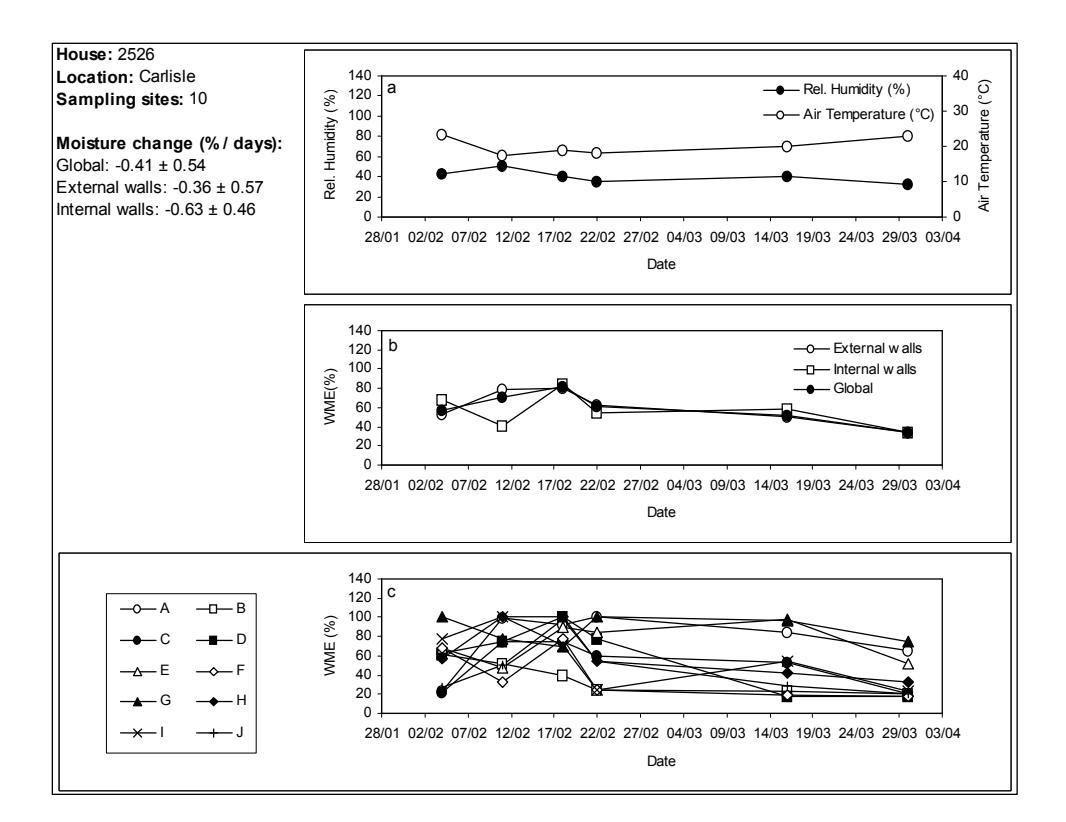
Figure 6. Moisture changes as WME in property 2526.

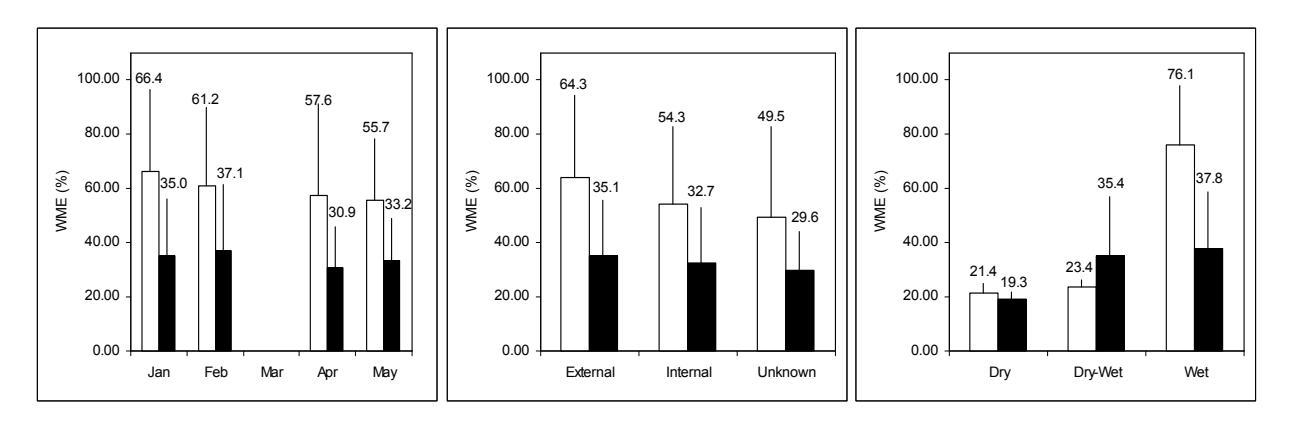
Figure 7. Initial and final moisture content at sampling points as wood moisture equivalent (WME) (mean + standard deviation; □, initial conditions; ∎, final conditions).

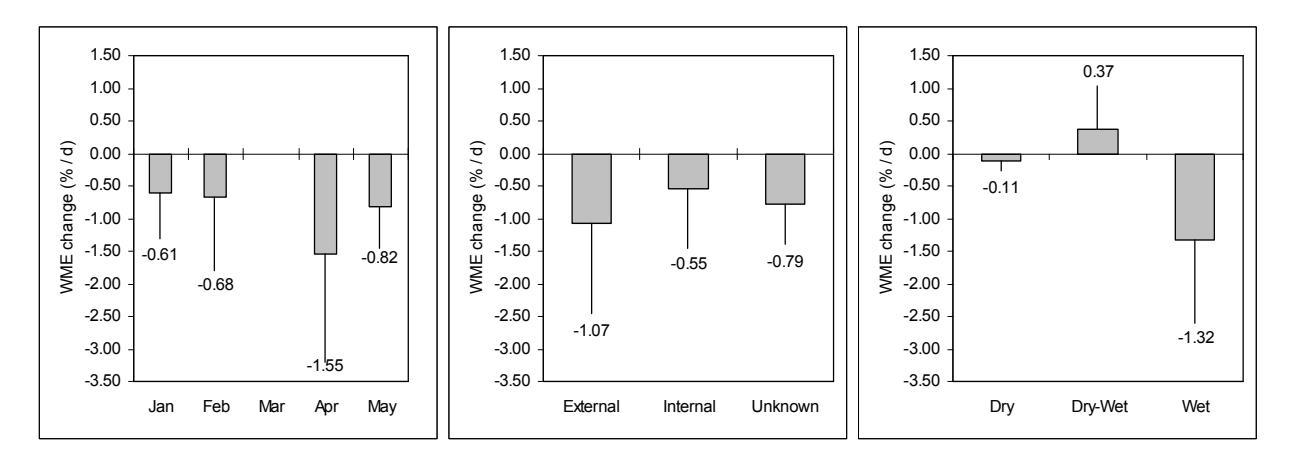
Figure 8. Moisture change (per day) at sampling points (mean + standard deviation) as wood moisture equivalent (WME).

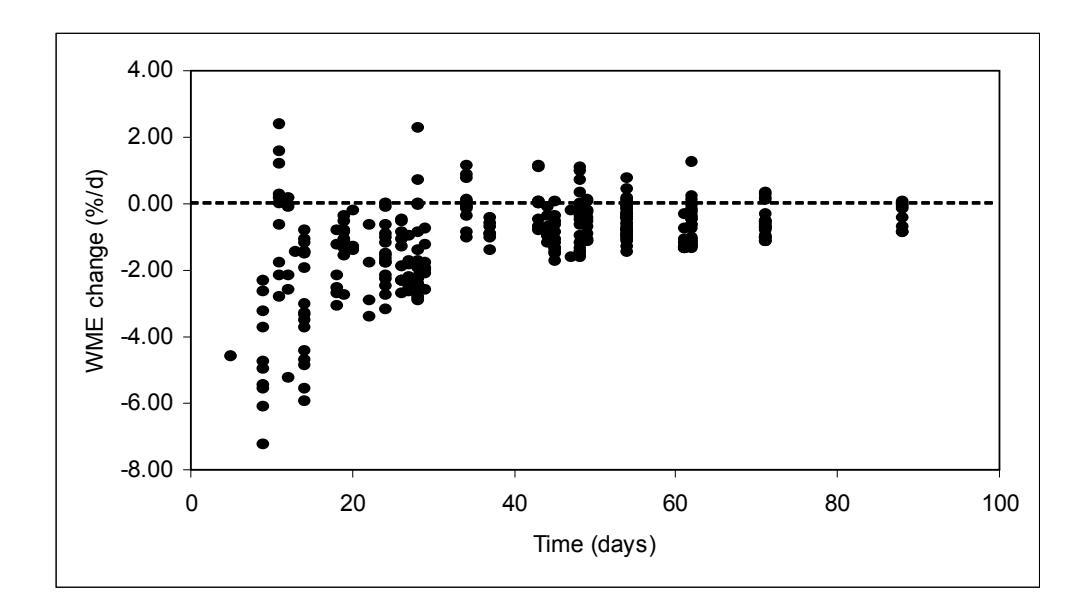
This higher drying rate from April is also reflected in Figure 9, which shows the duration over which the readings were taken, and the average drying rate over this period. So the highest drying rates occur over shorter periods (10-30 days), whereas the houses that were monitored from January (50-70 days) have rates of about -1% WME/d. One interesting point from this graph is that even after 60 days, some sampling points are showing an increase in moisture, although this could be due to inaccuracy in the sampling probes.

Figure 9. Wall moisture changes (wood moisture equivalent, WME) as a function of the length of the drying period. (n=307, data from dry sampling points were excluded from the graph).

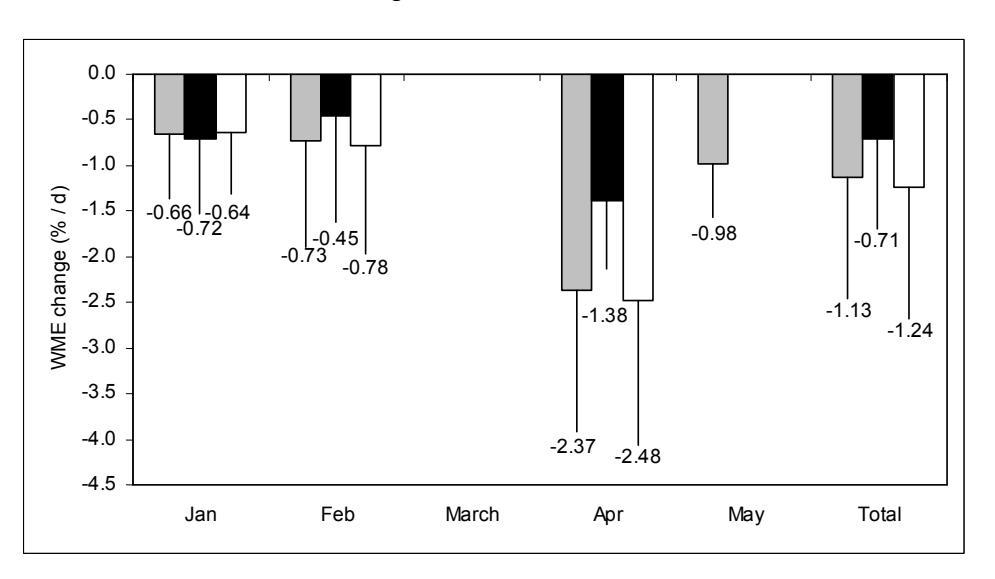
Looking specifically at the wet walls, Figure 10 presents the average drying rates based on all the sampling points. Figure 11 shows the average value for each house, which includes any 'dry' walls. These are not very different, as one would expect, and clearly show the higher drying rates in April and for external walls in general. This would seem to show the importance of the ambient conditions, with the higher spring temperatures helping to increase the drying of the external walls, and the house in general.

Figure 10. Wall moisture change in wet walls over the study period (mean moisture change + standard deviation; ■, wet walls in general; ■, internal walls; □, external walls). (n = 285, data from dry sampling points were excluded from the graph).

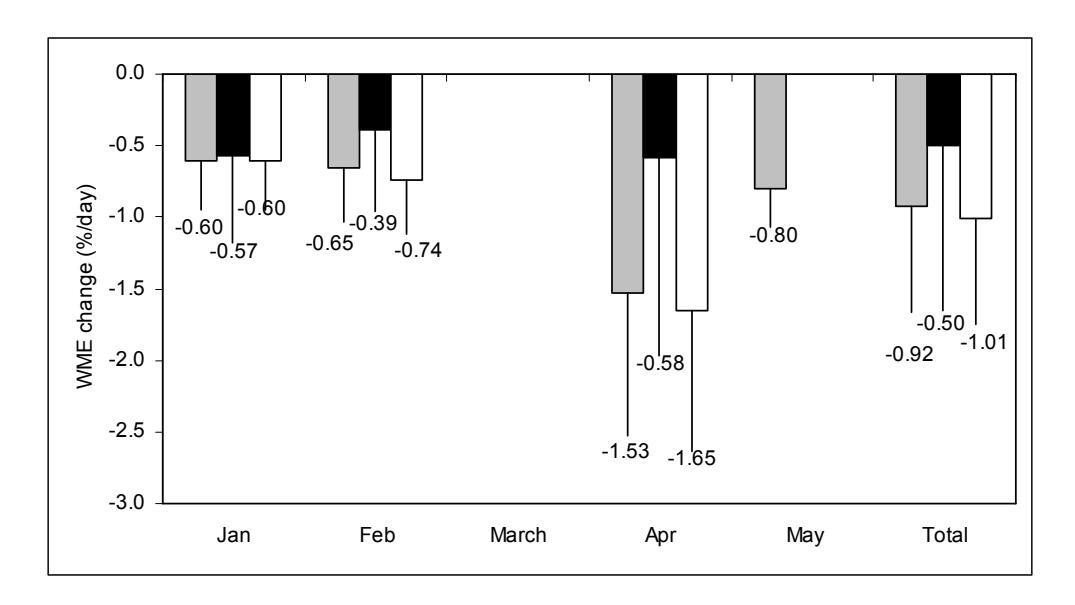
Figure 11. Moisture change (%/day) in flooded houses (mean moisture change + standard deviation; n = 35; ∎, overall house; ∎, internal walls; □, external walls).

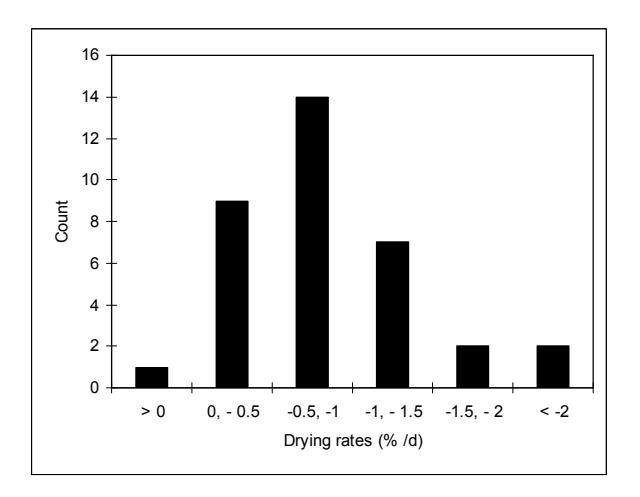
Figure 12 gives the distribution of drying rates for houses, showing that most values lie in the 0 to -1.5% WME range. The corresponding distribution for each wall sampling point is shown in Figure 13. This illustrates how some walls gained moisture over the recording period, and so have positive values, with the general drying rate again lying in the 0 to -1.5% WME range.

Figure 12. Frequency histogram of house-averaged drying rates (n = 35).

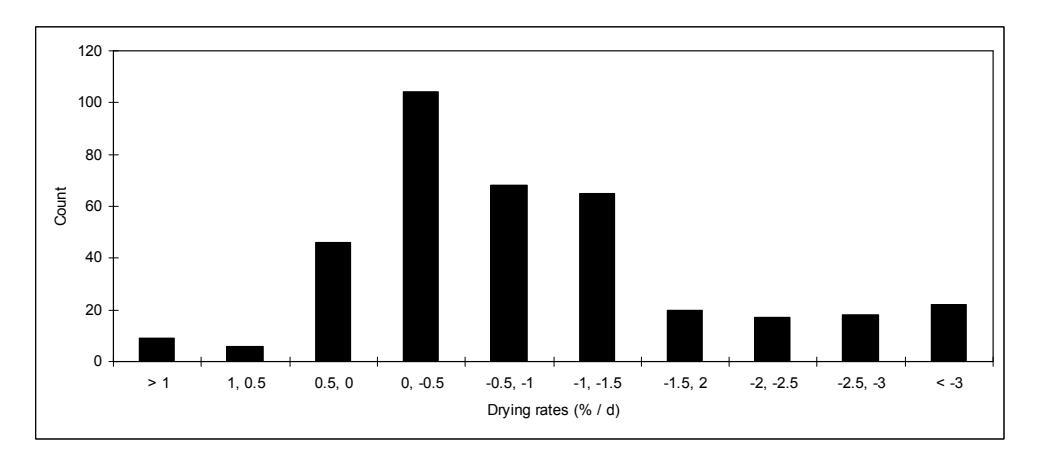
Figure 13. Frequency histogram of wall drying rates (n = 375)

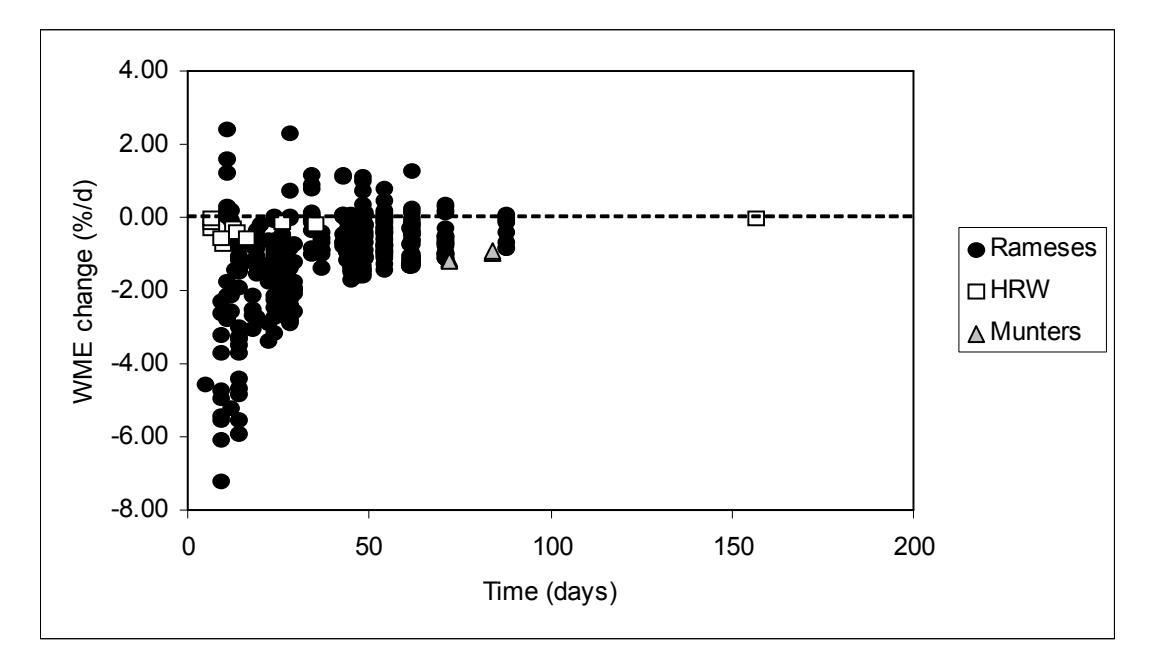
Figure 14. Wall moisture changes (wood moisture equivalent, WME) as a function of the length of the drying period.

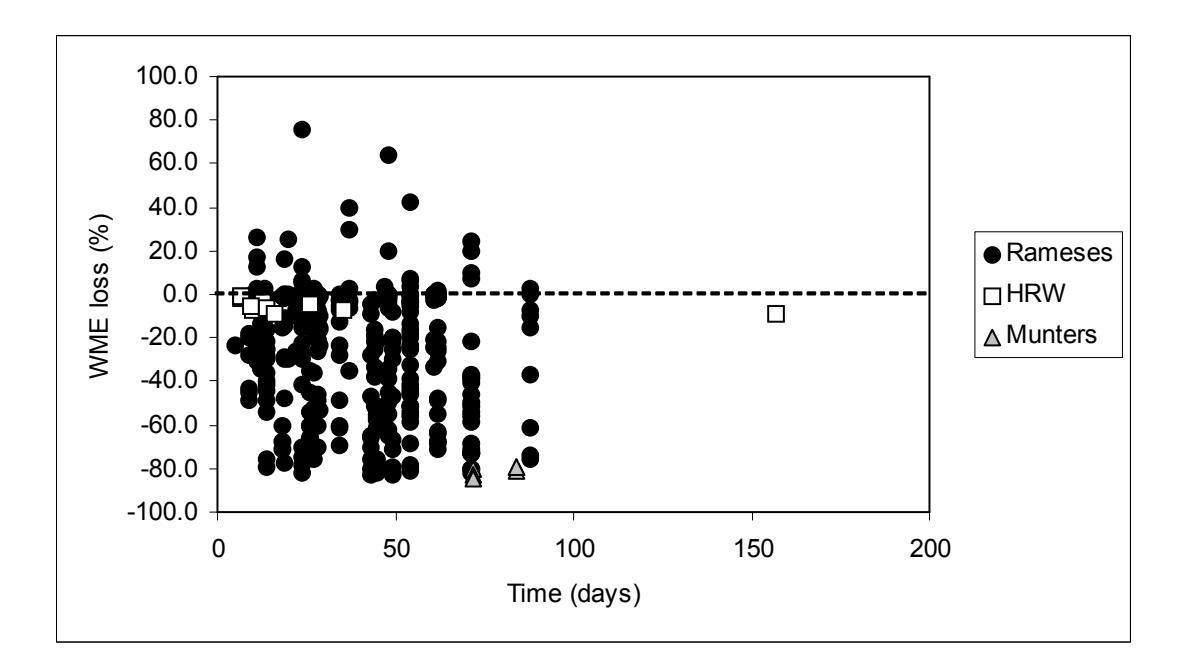
Figure 15. Wall moisture loss as a function of time
