Chief Executive

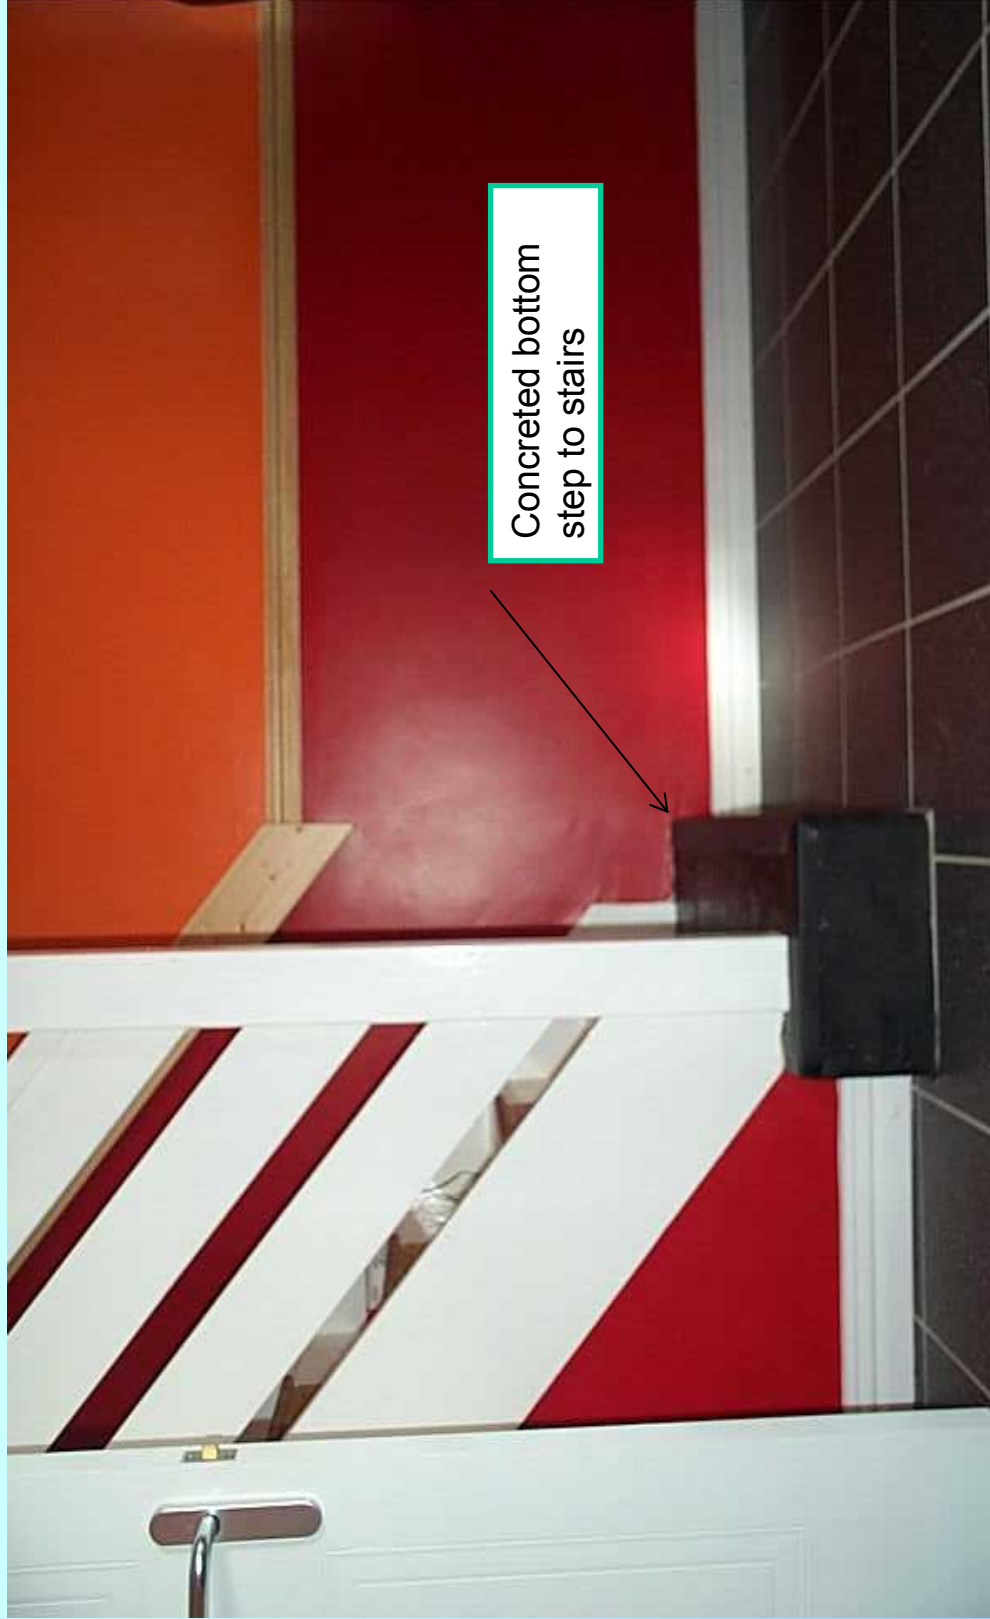
Lime
limestone
plaster
walls

Ceramic
floors

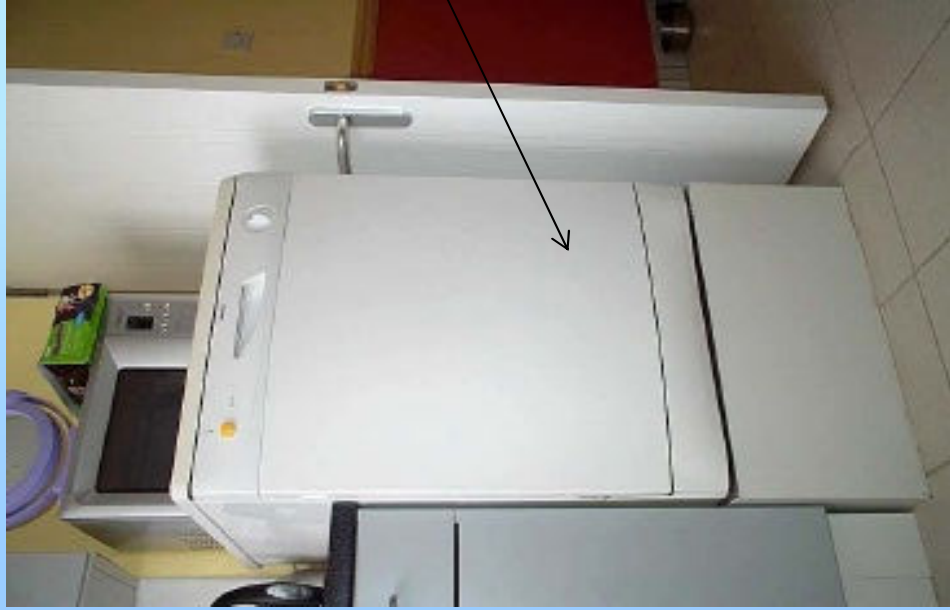
Main
appliances
raised up
on plinths

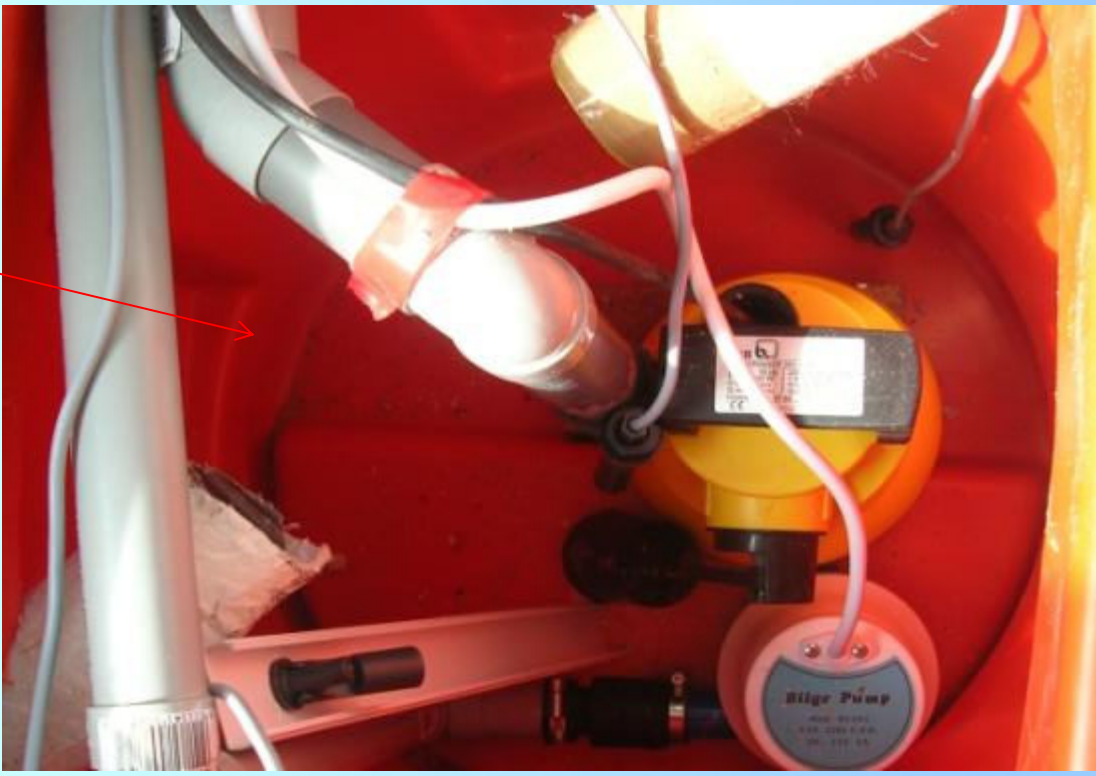
sump

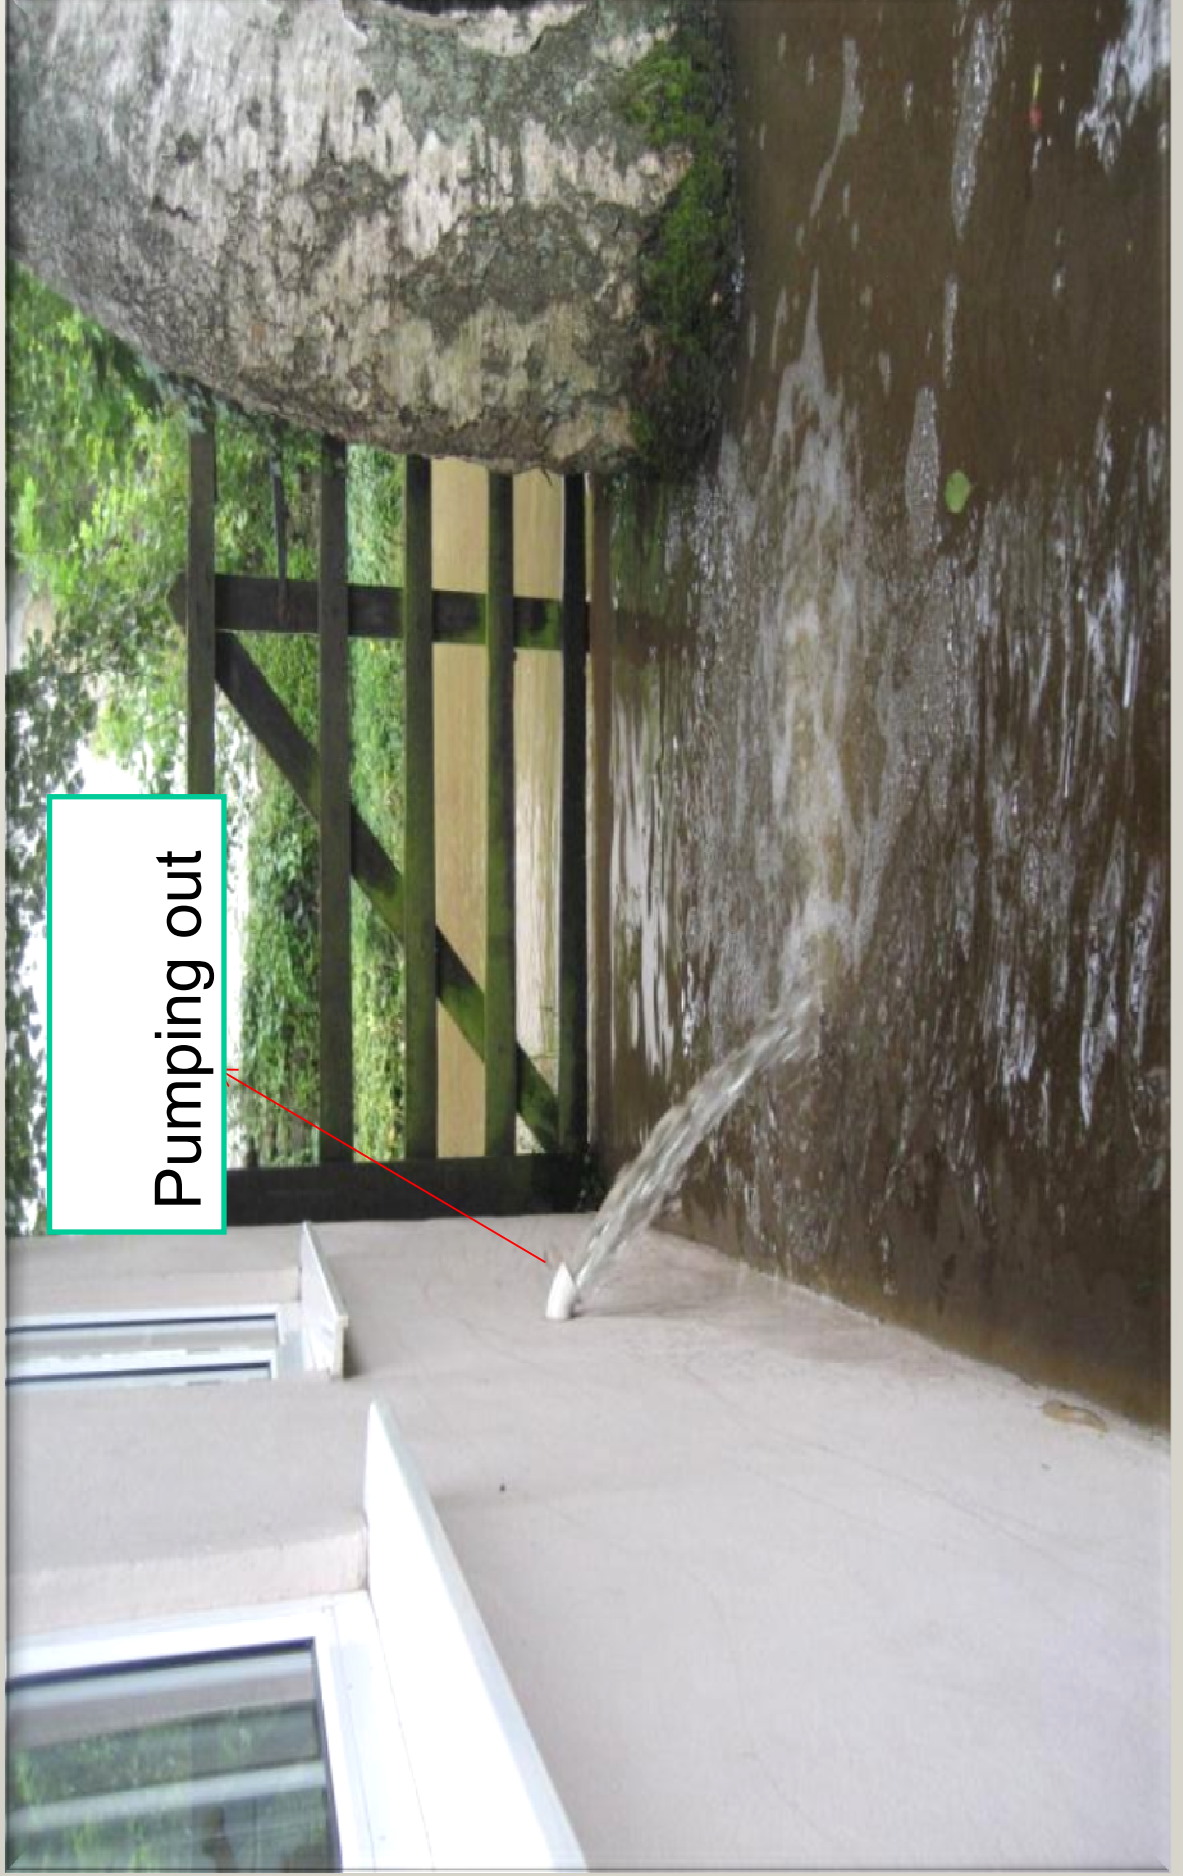
Pumping out

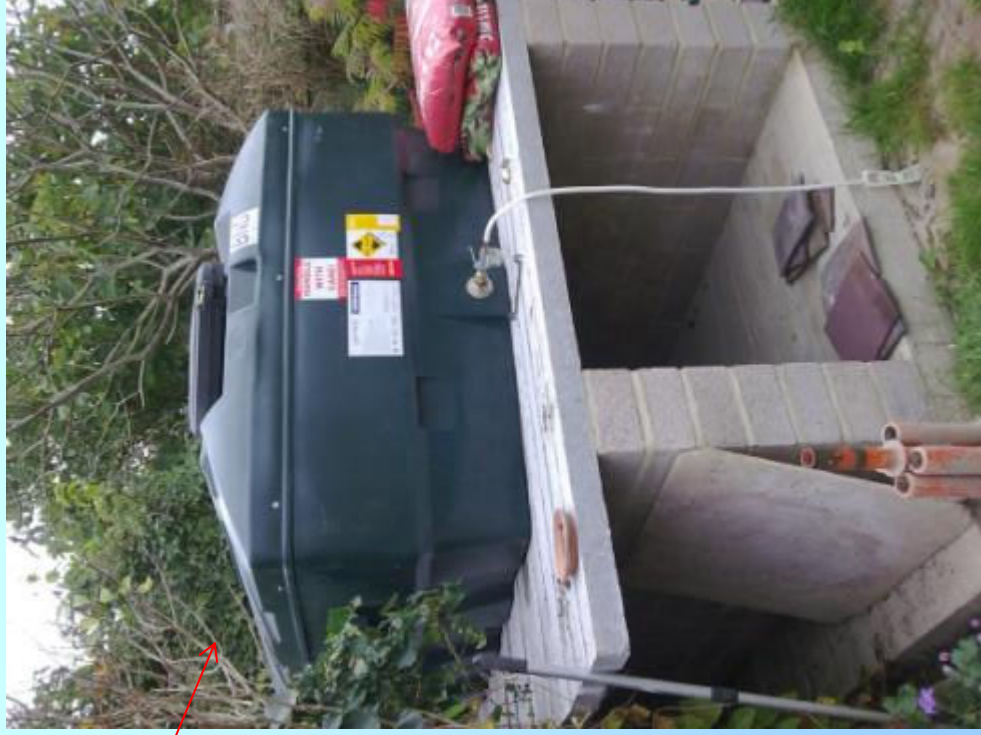
Oil tank placed
above flood height

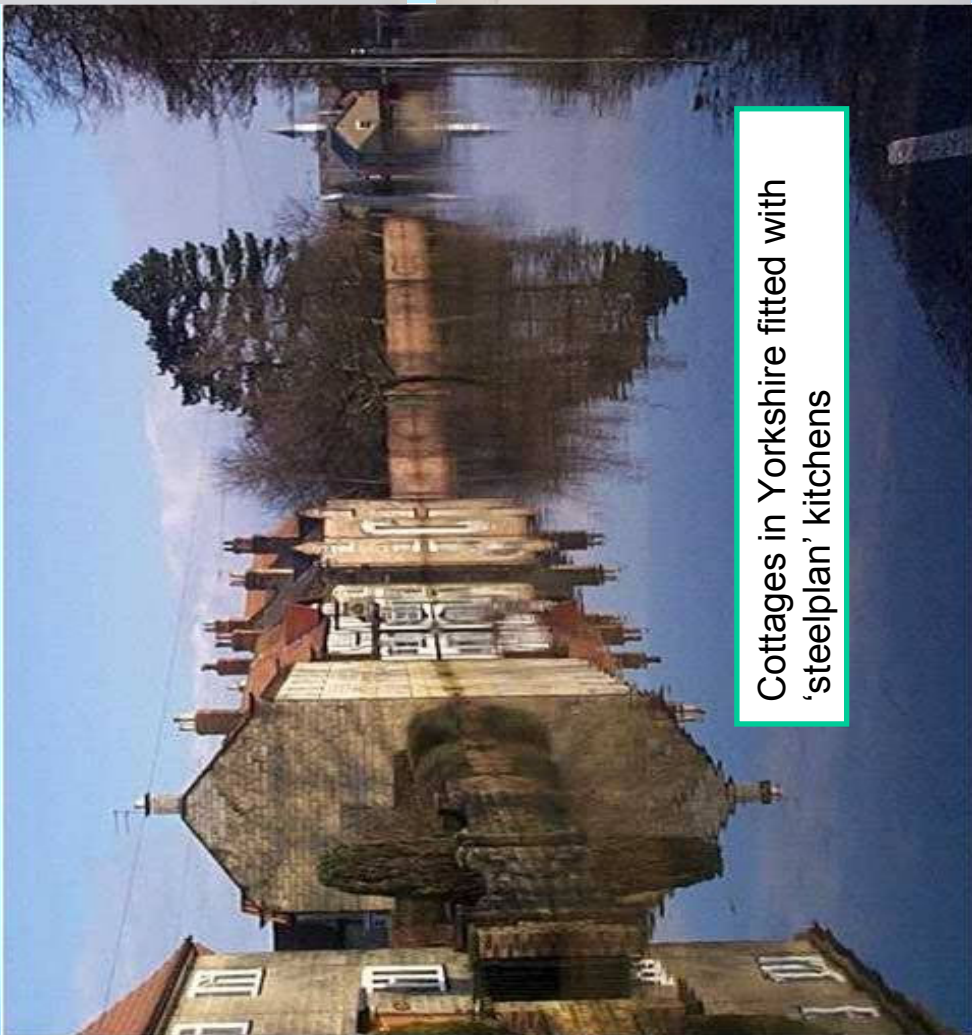
Cottages in Yorkshire fitted with 'steelplan' kitchens

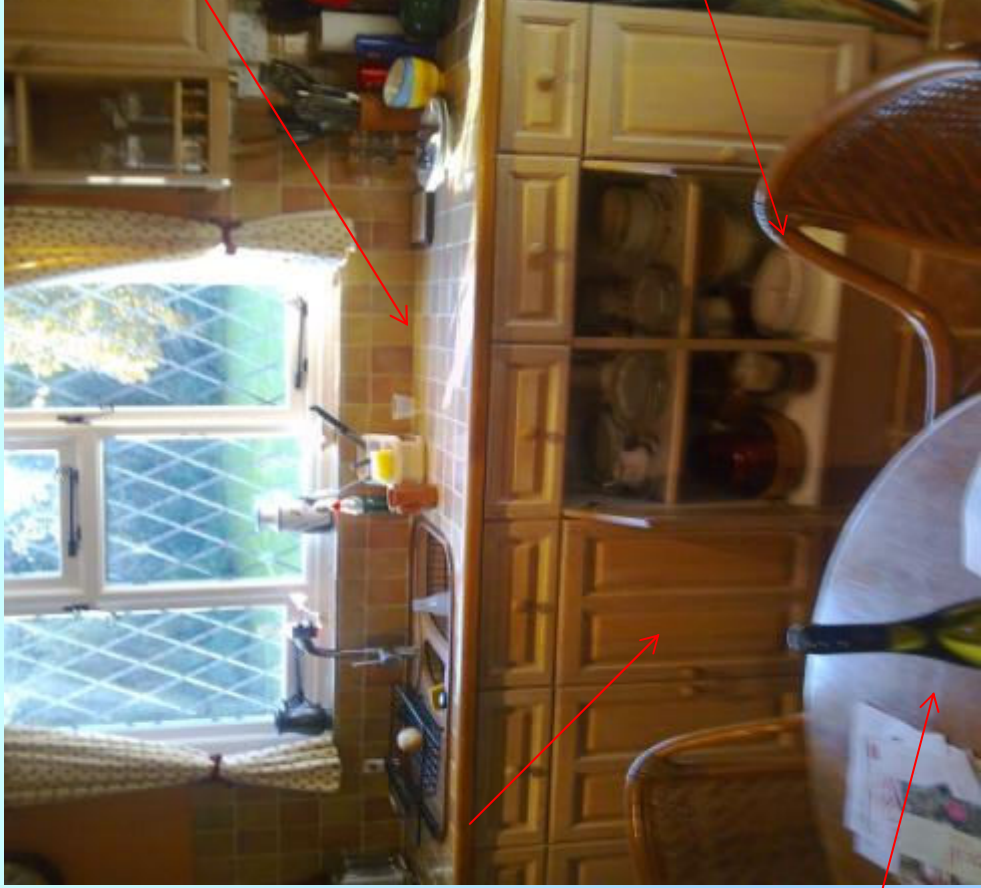
Removable
cupboard back
and ceramic
tiles behind for
easy washing

washable
plastic carcass

Removable
cupboard
doors
